Summary

AmeriSpec MidSouth

123 Sample St Germantown TN 38139

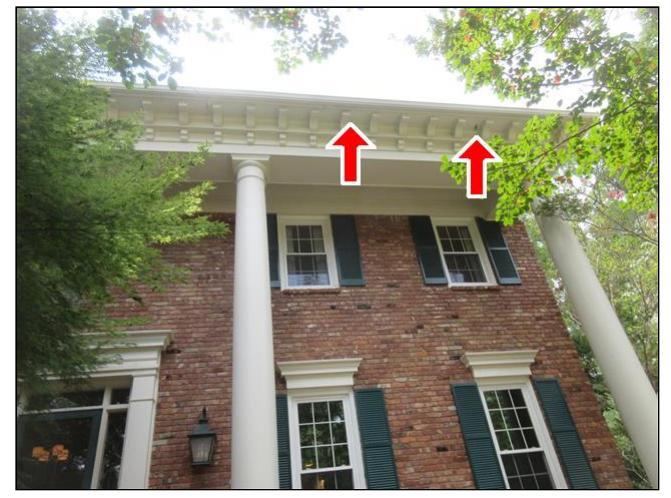
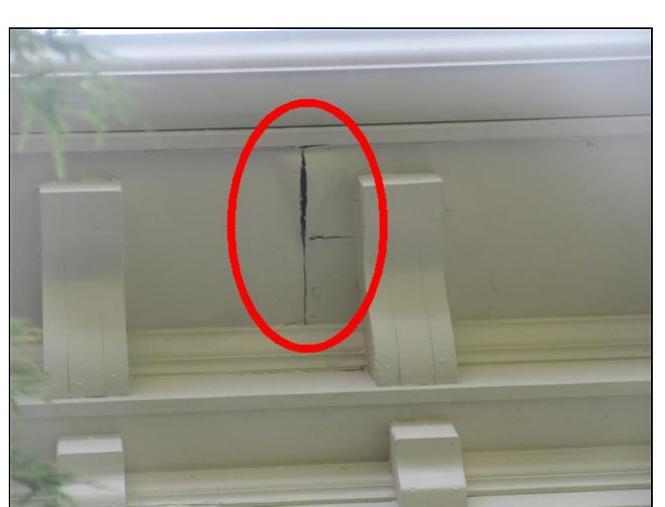
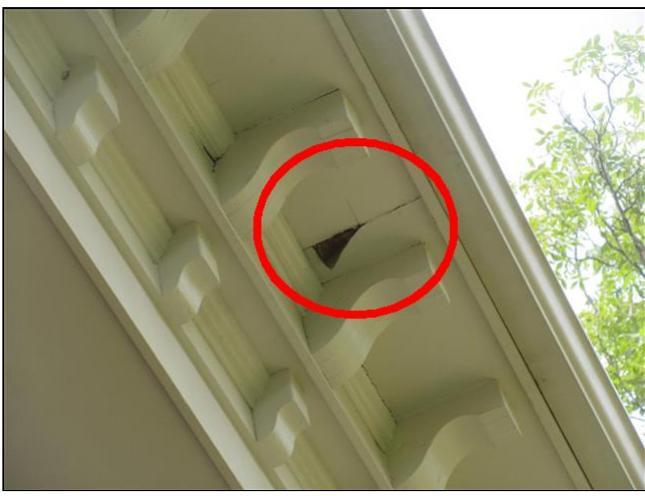
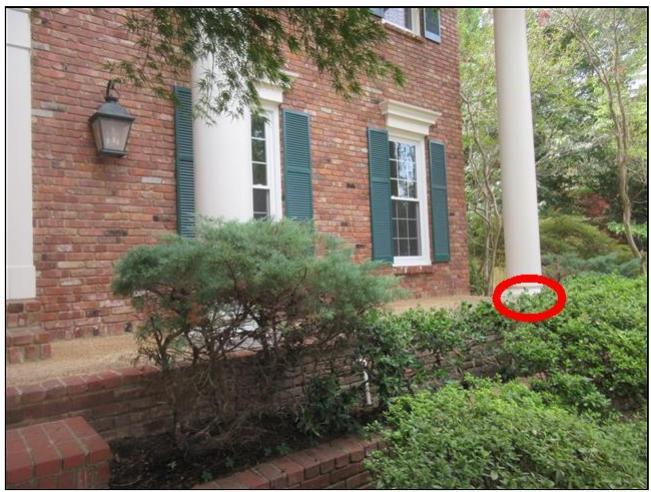
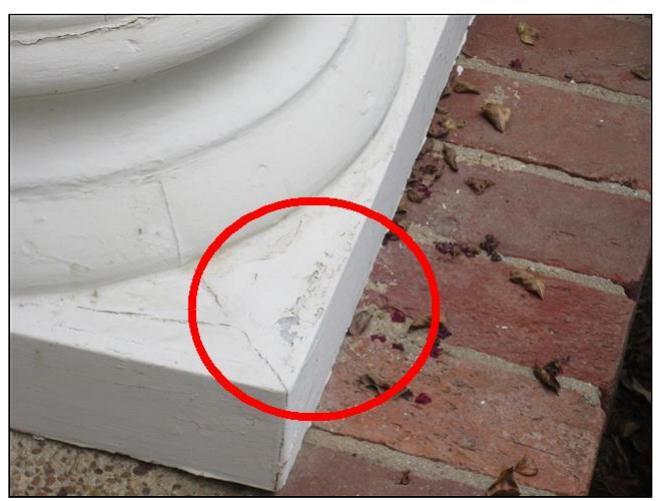
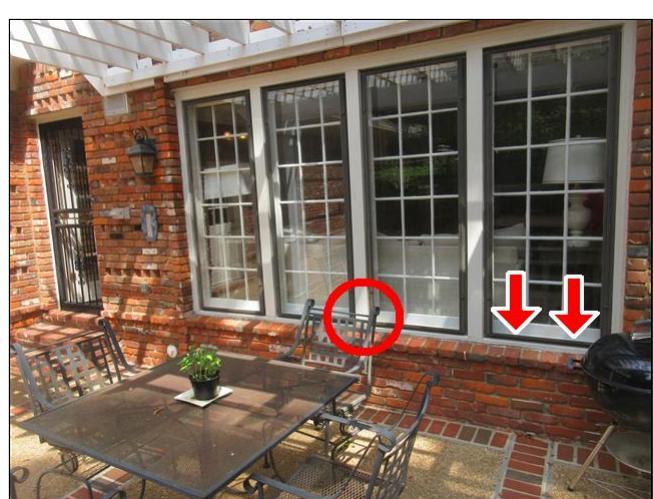
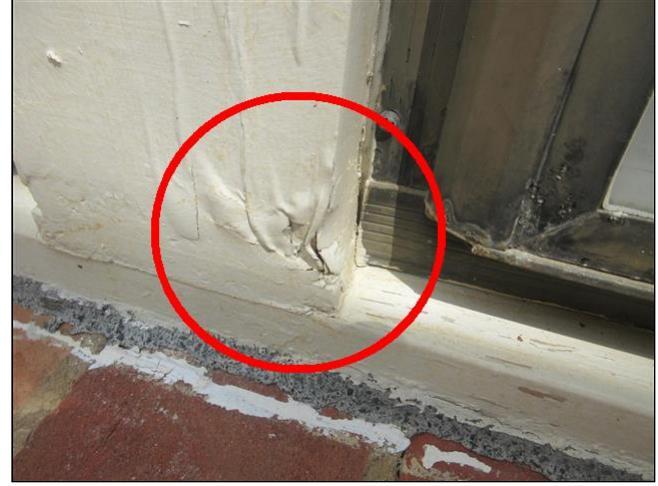
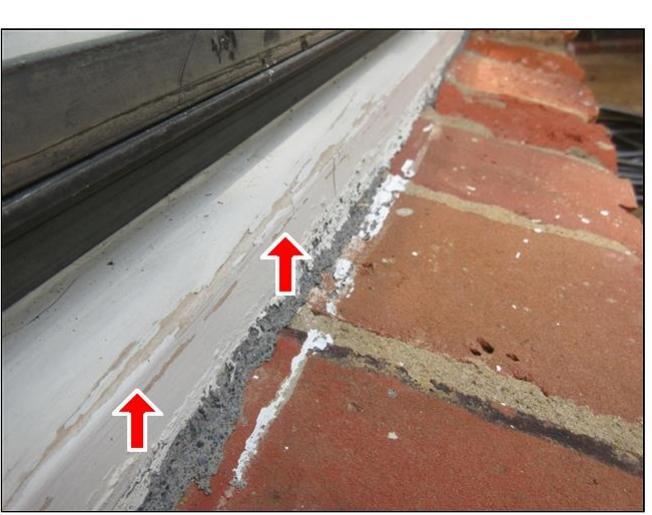
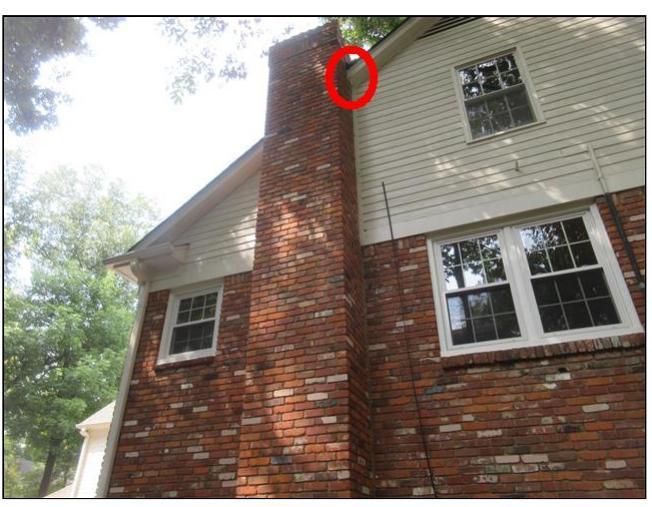
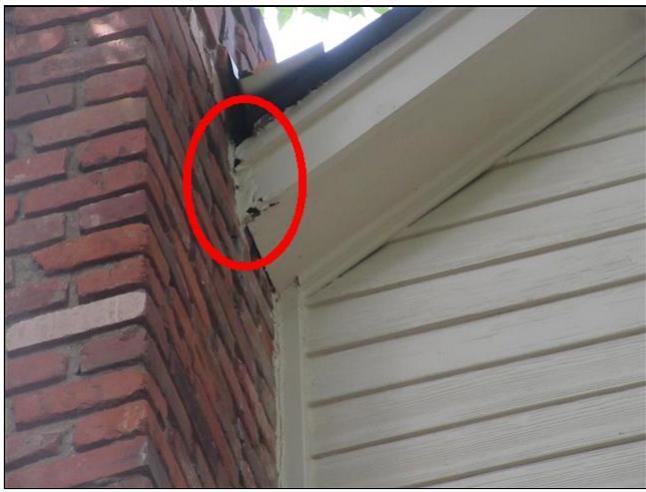
(1) Moisture damaged wood observed at various locations. The extent of damage could not be determined without destructive analysis (maintenance and/or repairs should be performed).

The wood trim needs primer and paint at various locations. I recommend a qualified contractor correct as needed.

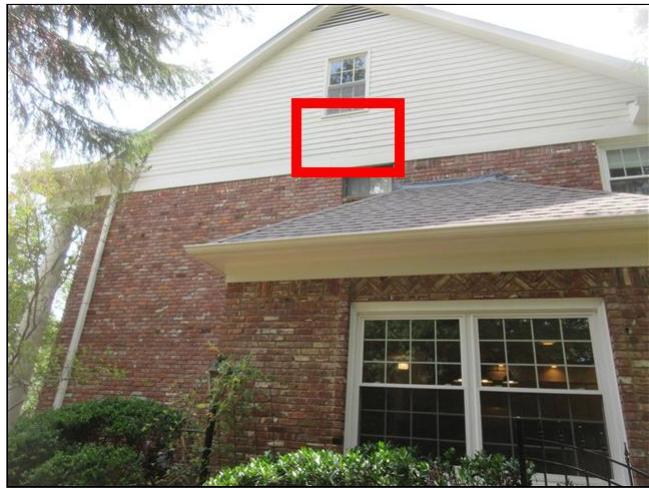
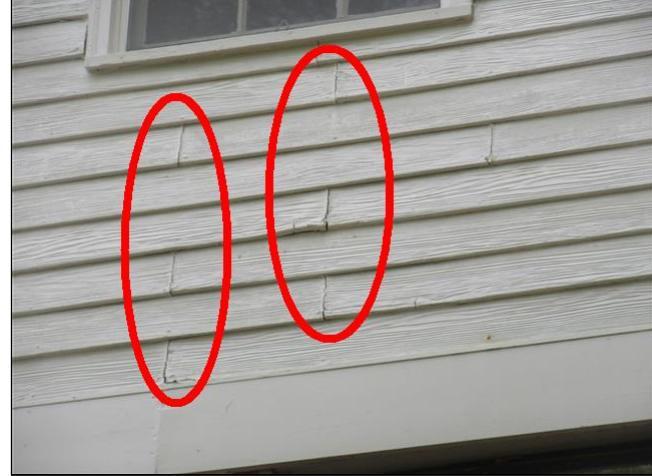
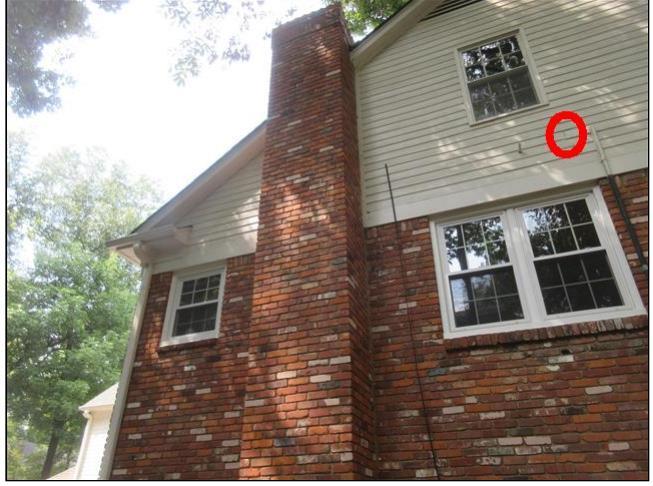
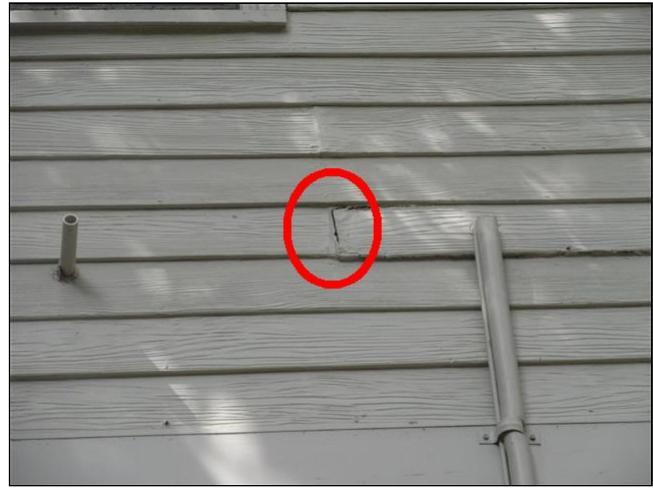
(2) Recommend adding caulk/paint to end joints of siding where necessary to prevent water penetration/deterioration.

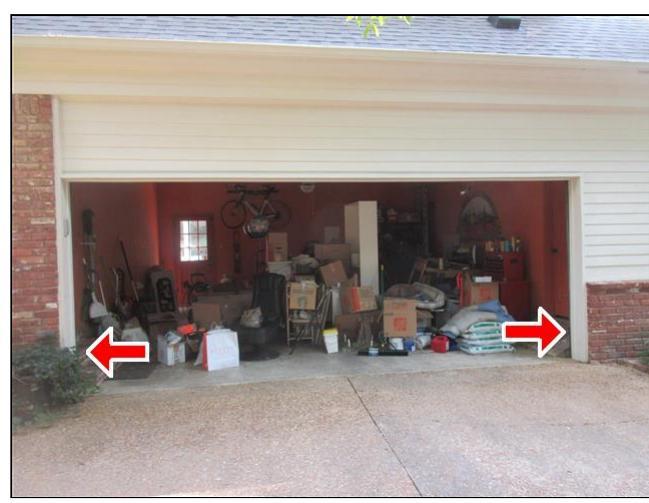
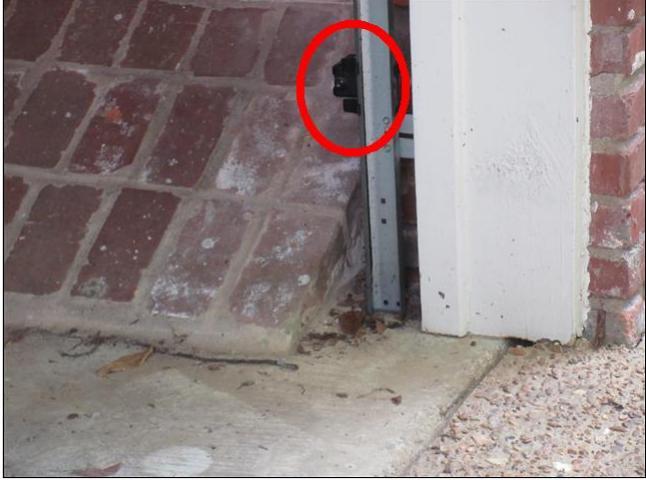
(1) The electric eyes are mounted too far above the floor to protect small children, pets, or property as intended by the manufacturer. We recommend lowering the eyes to within 6-8 inches of the floor or manufactures specifications.

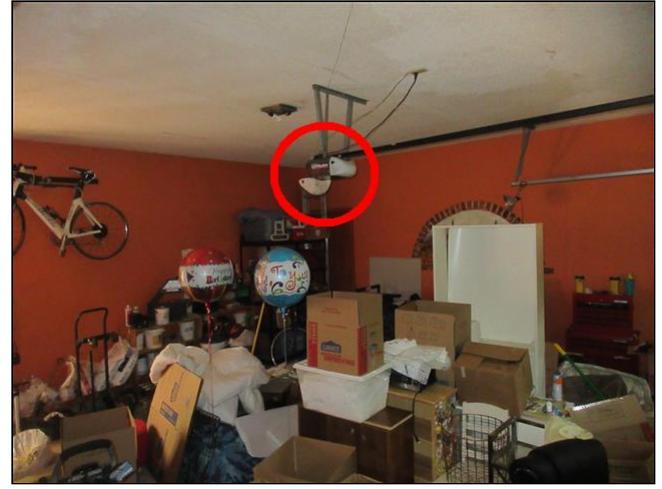
3.2 Item 3(Picture)

(2) The force activated safety reverse did not respond to test. This garage door opener is to be equipped with dual safety reverse devices, one of which did not operate when tested at the time of inspection. Recommend review for repair or adjustment, as necessary.

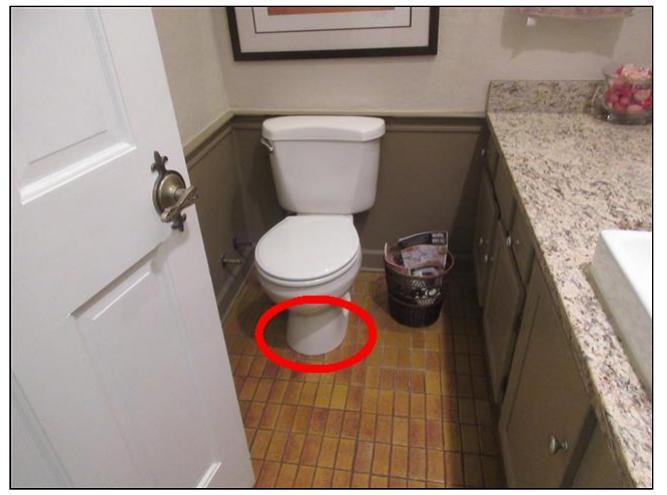
The toilet bowl is loose at floor anchor bolts in the first floor hall half bathroom. The wax ring inside the unit must have a snug, secure fit in order to keep from leaking. Properly re-sealing and resecuring this unit is suggested to prevent water leakage and damage to the sub-floor area. This type of damage is not always visible or accessible to the inspector at time of inspection. Recommend review by a qualified plumber for repair or replacement, as necessary.

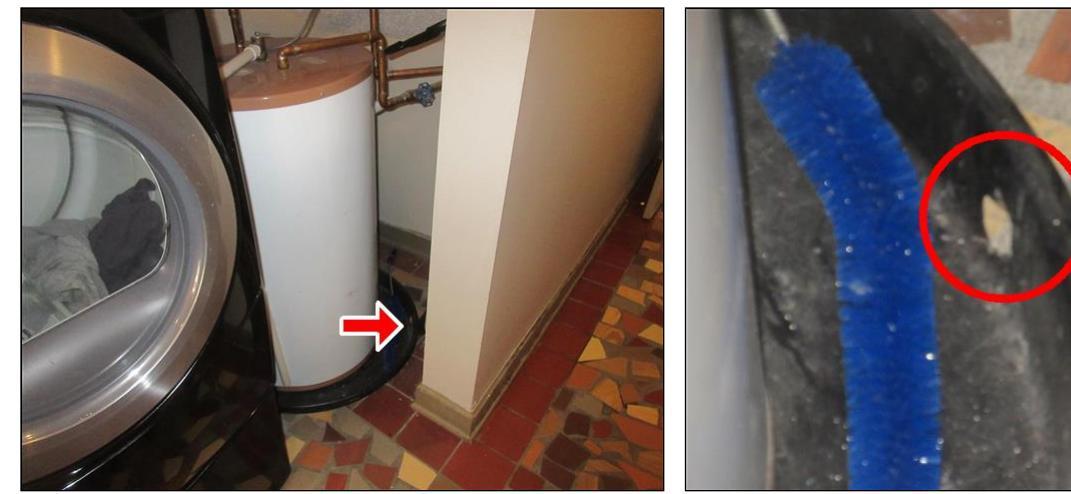
(1) Damaged emergency pan observed at the hot water heater located in the laundry room. Recommend repair/replacement for proper operation.

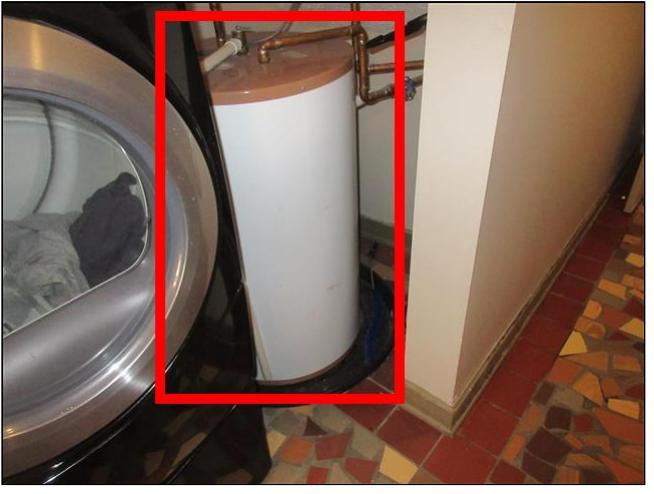
5.1 Item 3(Picture)

(2) In the inspectors opinion the water heater in the laundry room could be near the end of its useful life due to its age. Recommend review by a licensed plumber for repair or replacement, as necessary.

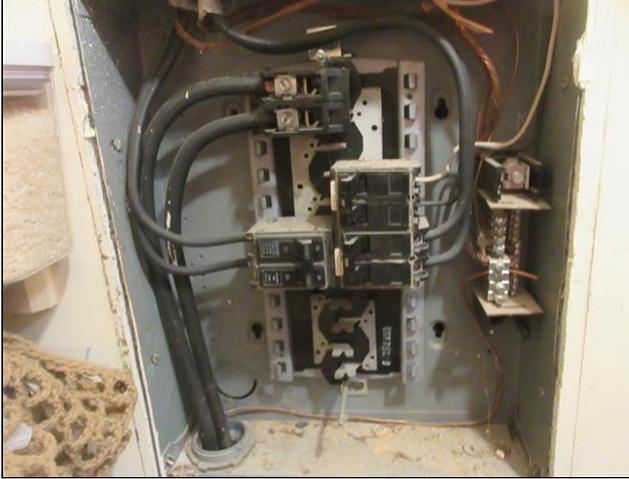
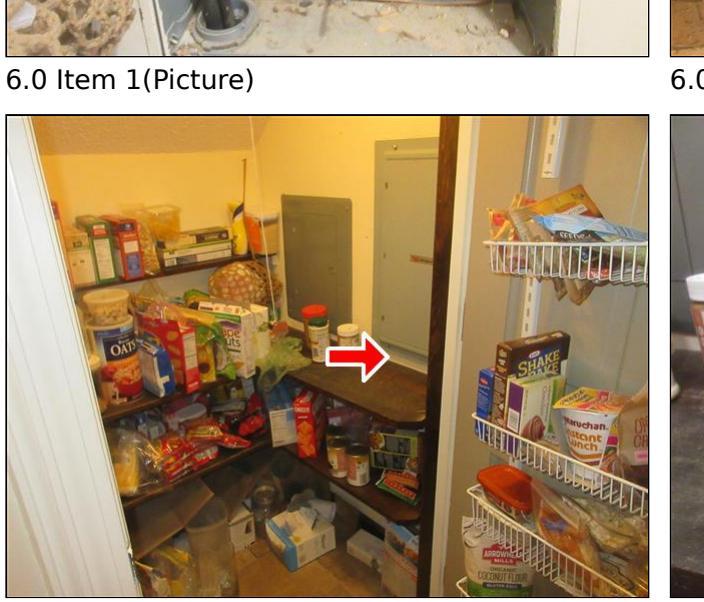
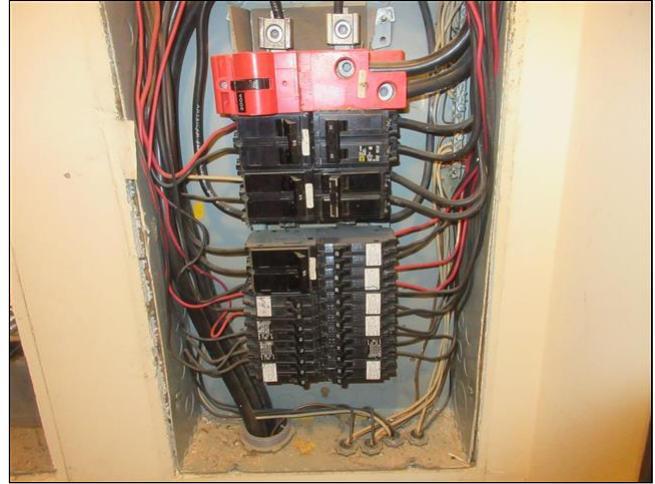
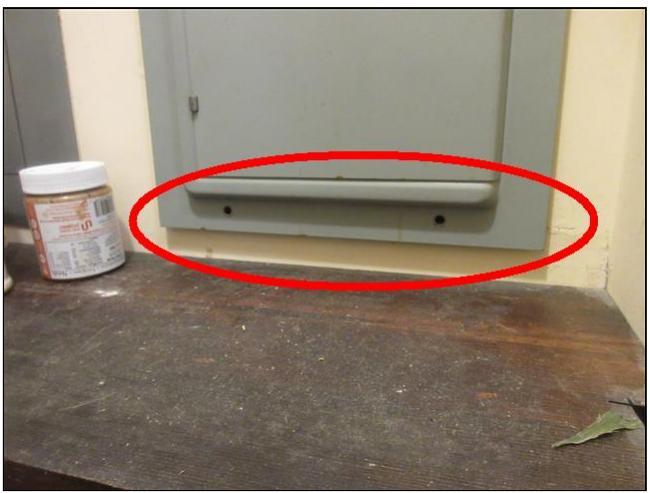
The main electrical panel is located along the right side wall of the kitchen pantry. The protective cover was removed for this photo and a more thorough inspection.

Recommend missing electrical panel screws be replaced for safety.

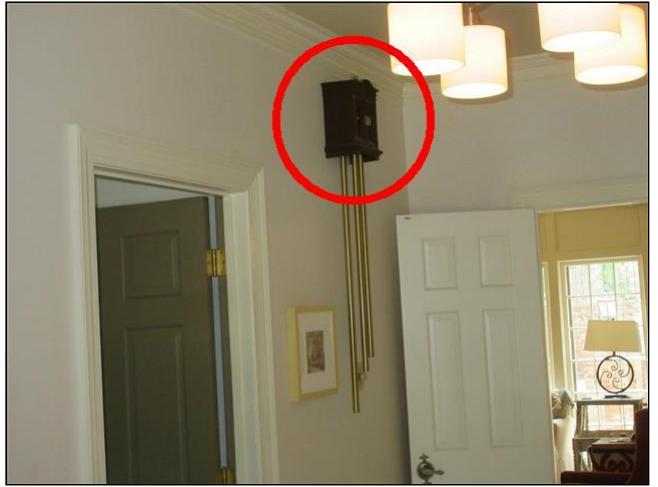
6.1 Item 1(Picture)

(1) Damaged doorbell observed. Recommend repairs be made for proper operation.

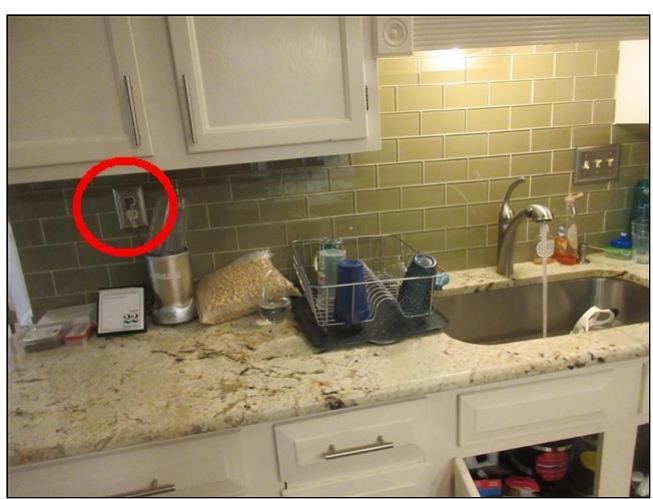
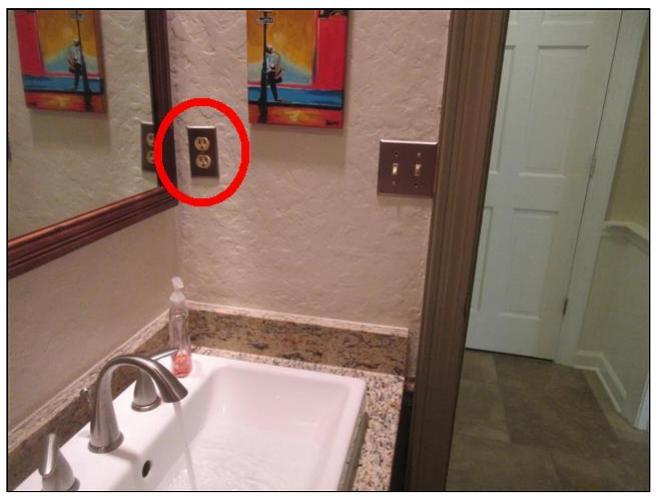
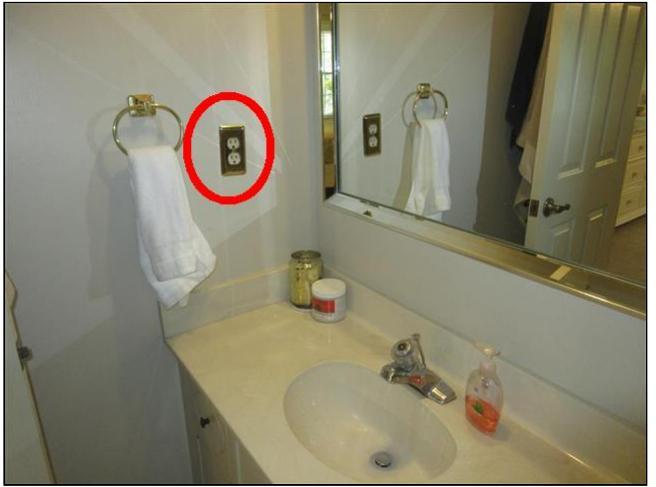
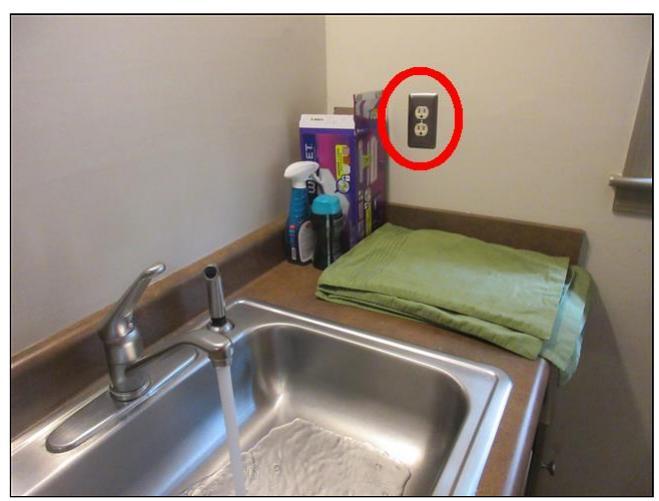
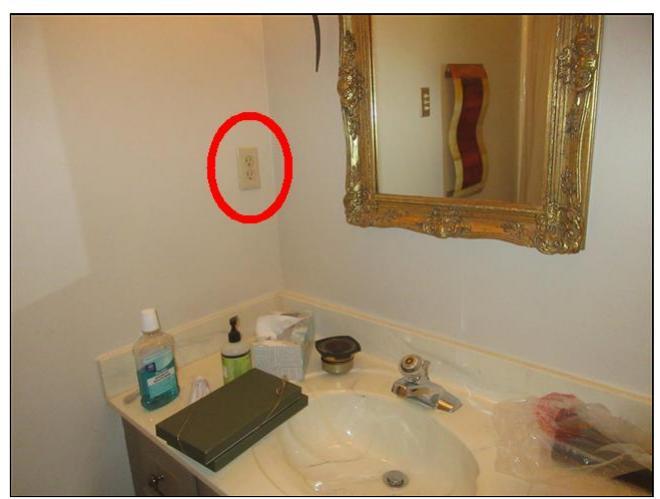
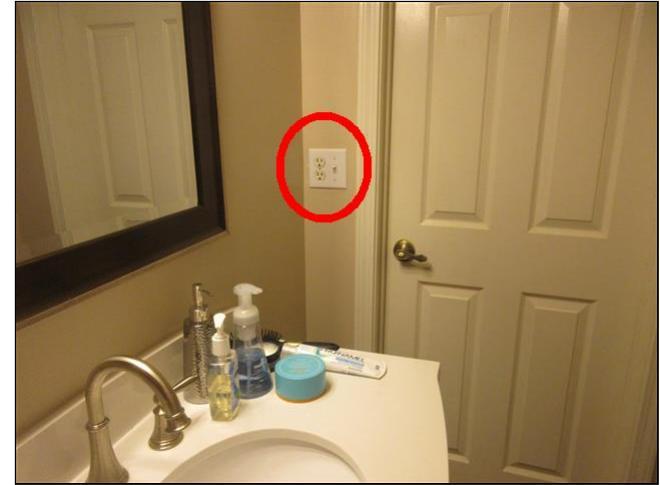
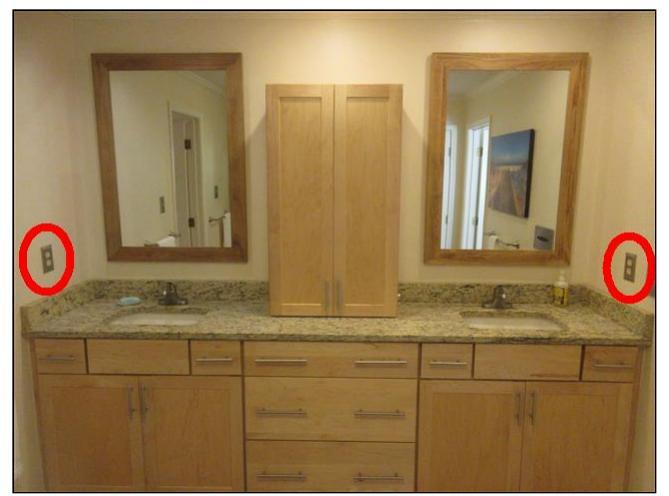
(2) Ground Fault Circuit Interrupters (GFCI) may not have been required when the home was built. Suggest client consider upgrading with ground fault circuit interrupters (GFCI's) at all receptacles near water sources, such as the kitchen, the bathrooms, the garage, and exterior receptacles to enhance safety. Upgrades should be performed by a licensed electrician.

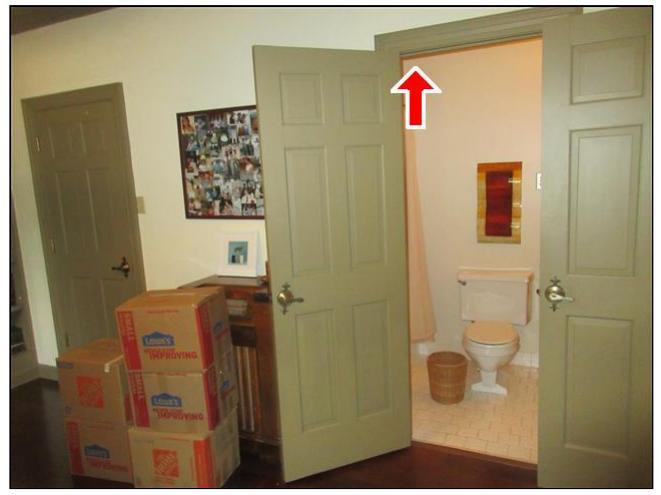
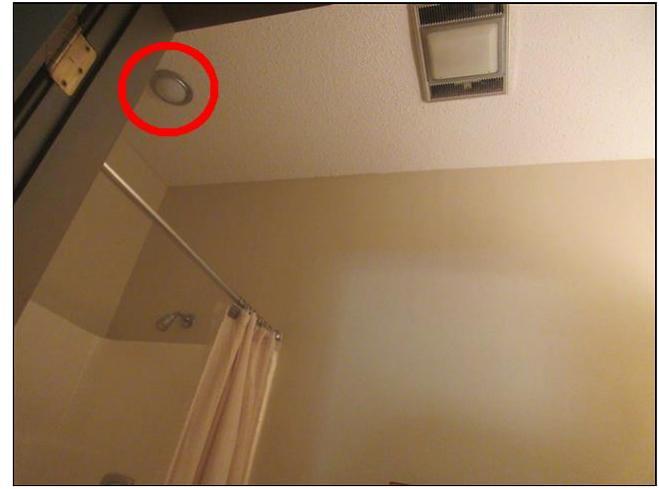
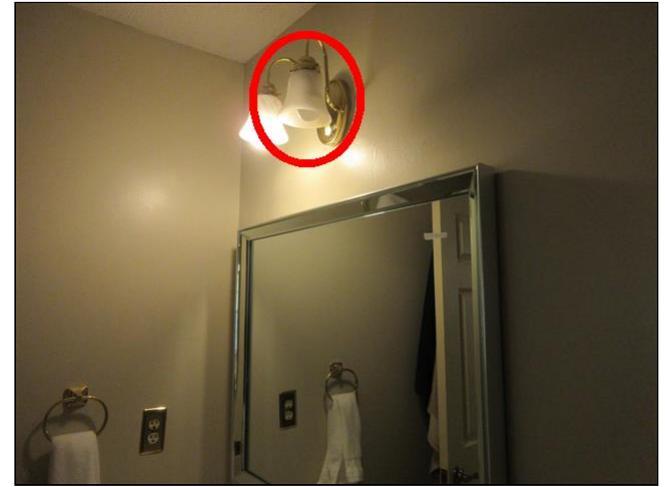
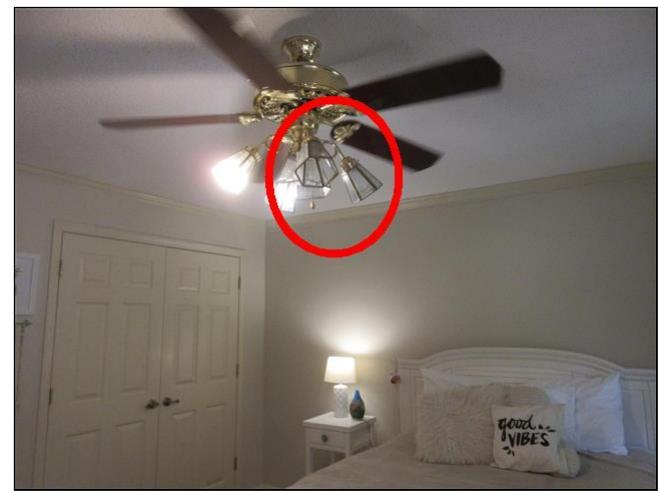
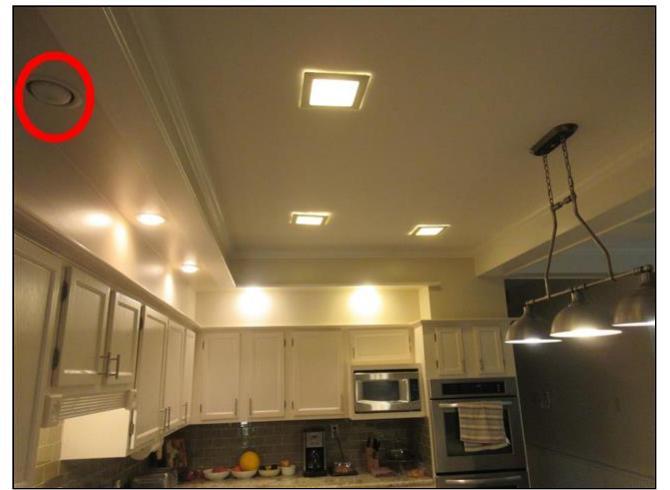
(3) Light fixtures in various locations were inoperative at time of inspection. Possible spent bulbs. Suggest client verify fixtures for proper operation prior to closing.

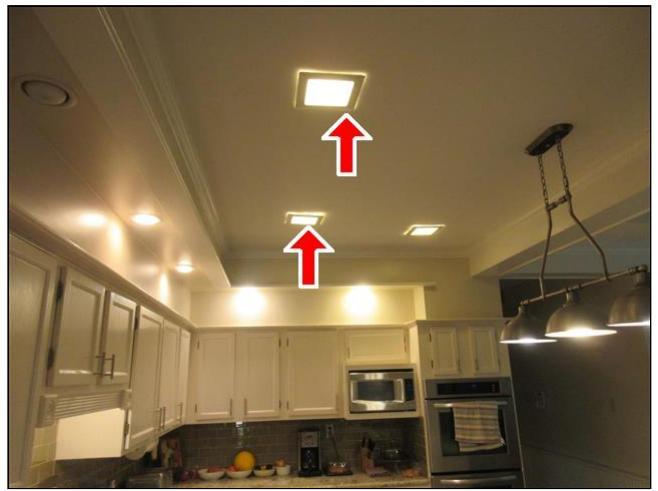
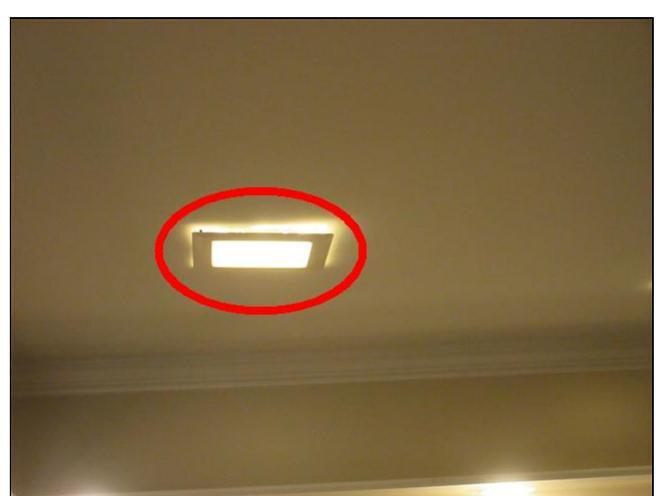
(4) Damaged light fixtures observed in the kitchen. Recommend repairs be made.

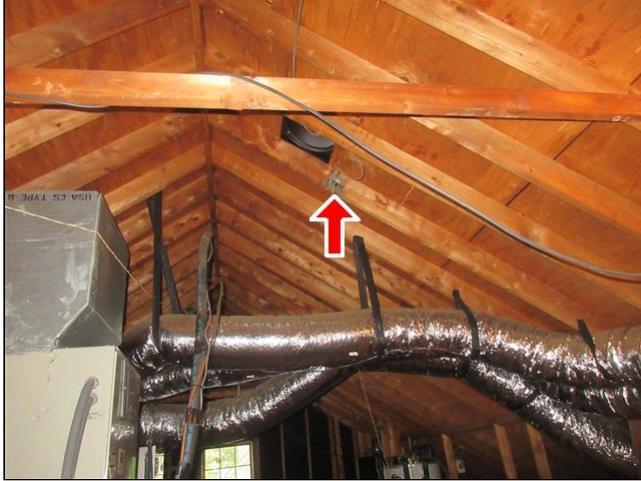
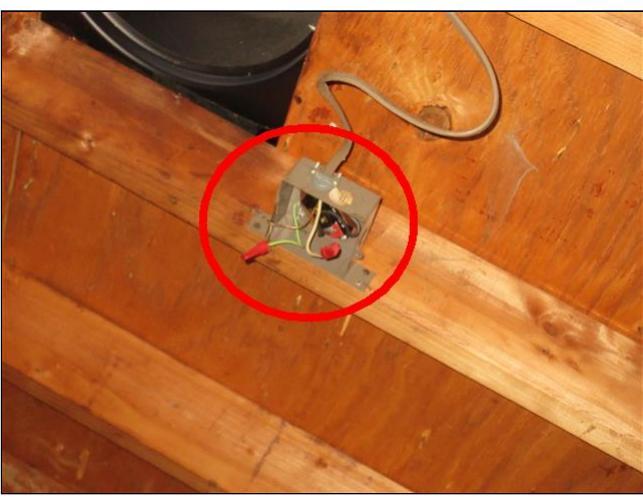
(6) Open junction boxes were observed in the attic. Whenever an electric wire is cut and reconnected, the 'splice' should be encased in a covered junction box to prevent shocks and separation of the splice.

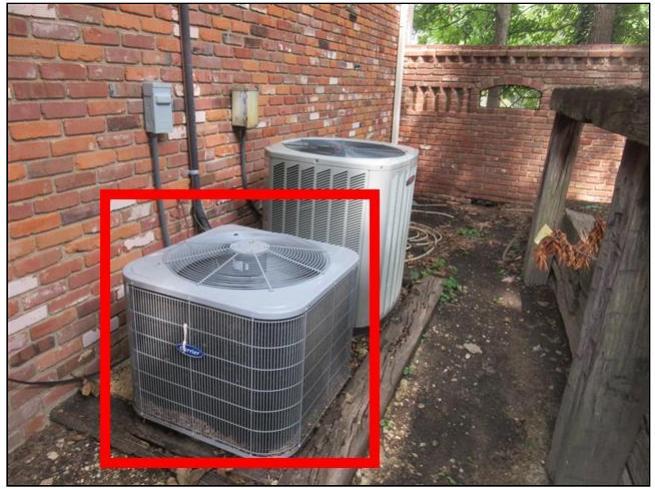
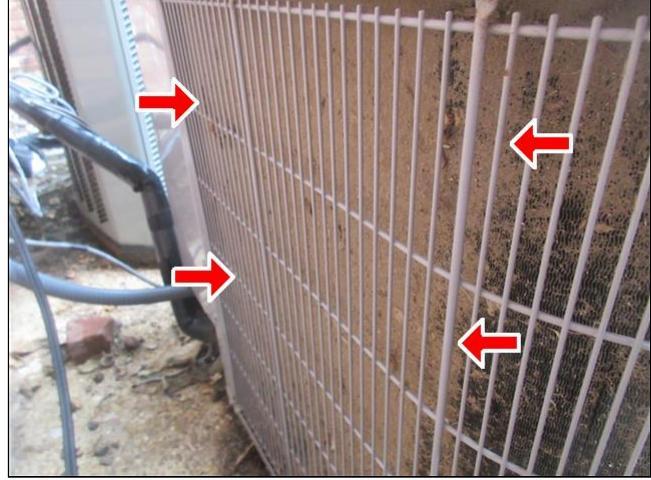
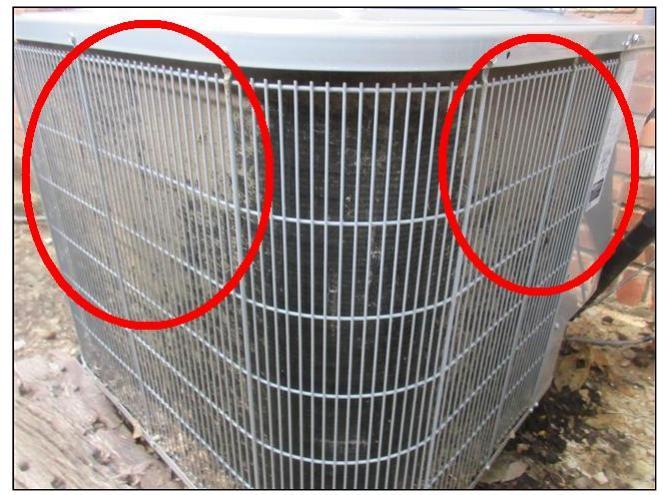
(1) Recommend having the condensing unit cleaned as part of routine maintenance.

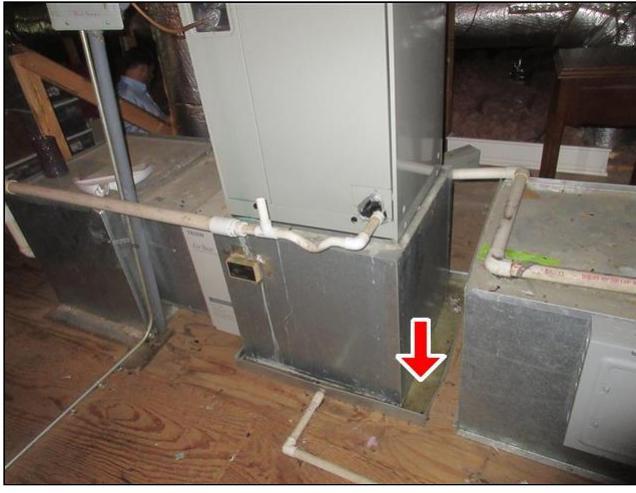
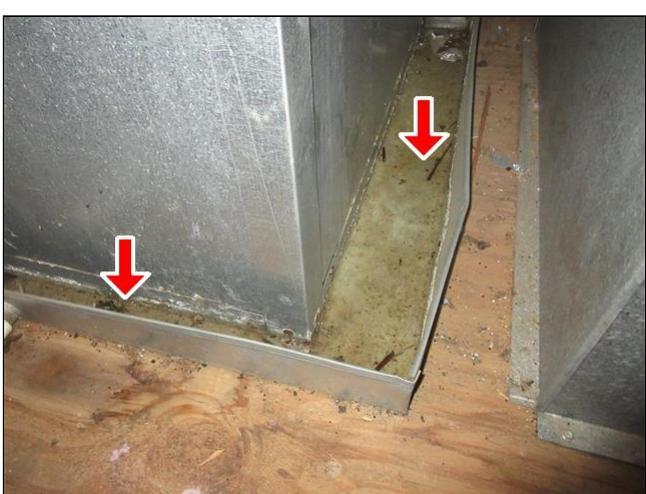
(2) Water observed in the emergency overflow pan of the HVAC. Recommend further inspection by a licensed HVAC technician for repairs/replacements to be made as necessary.

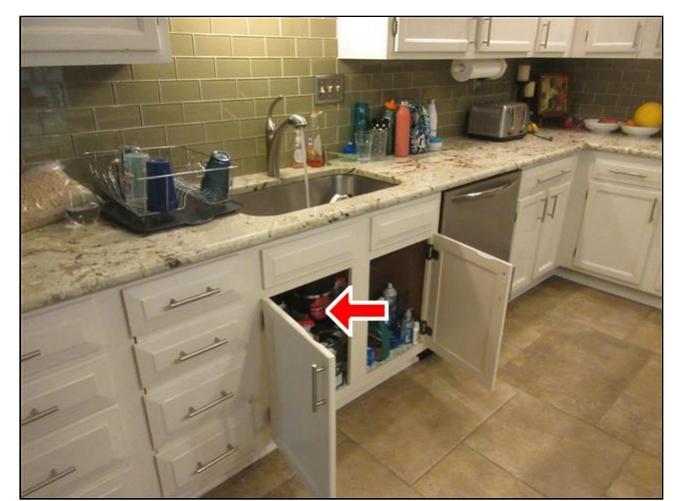
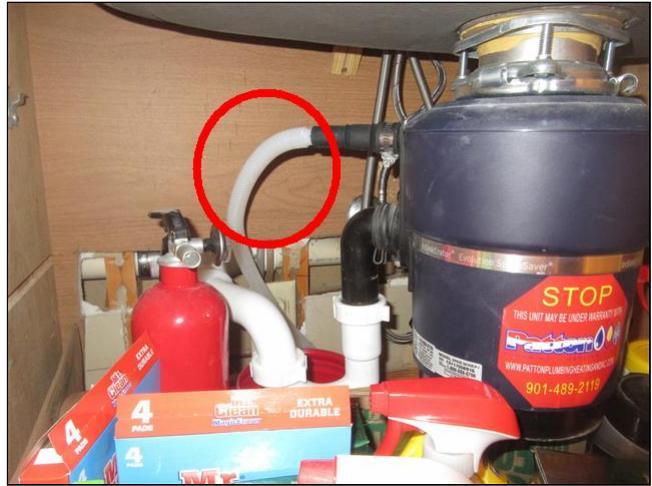
The dishwasher drain line needs to be looped upward near the top of the cabinet underside in order to prevent possible contamination of clean dishes which can occur when water from the sink flows into the dishwasher.

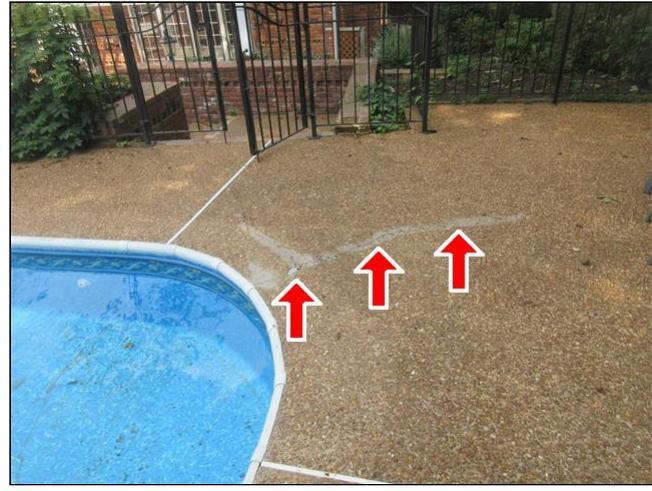
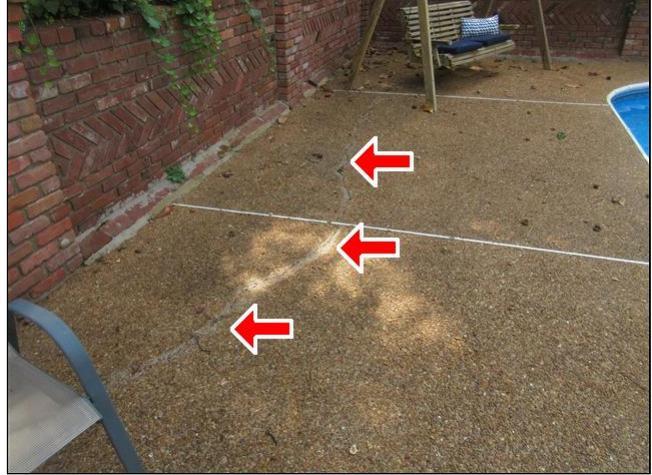
Recommend sealing pool decking cracks in the future to prevent water penetration.

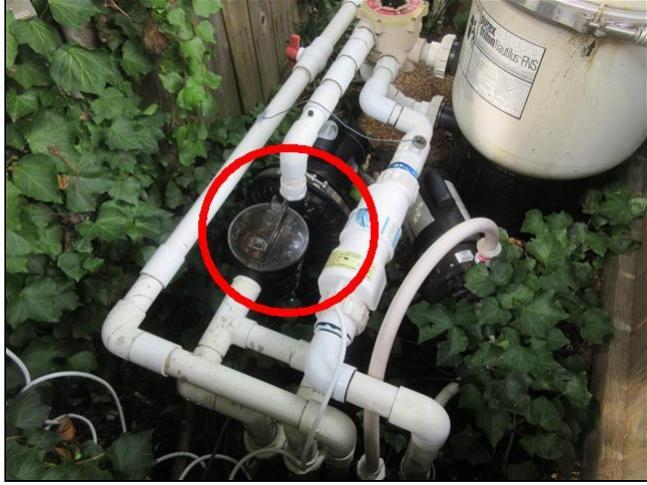
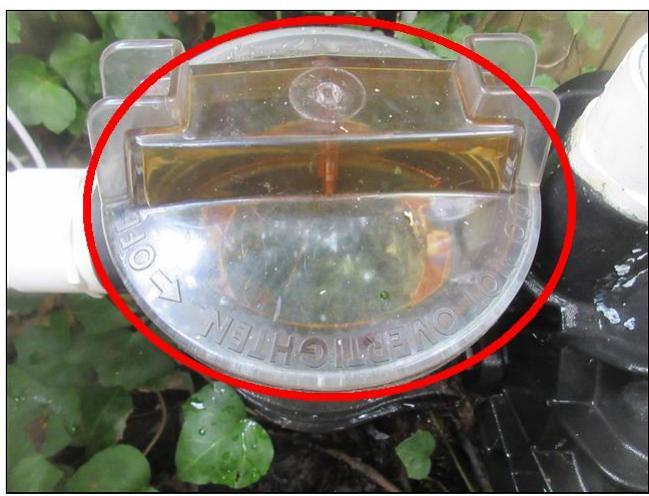
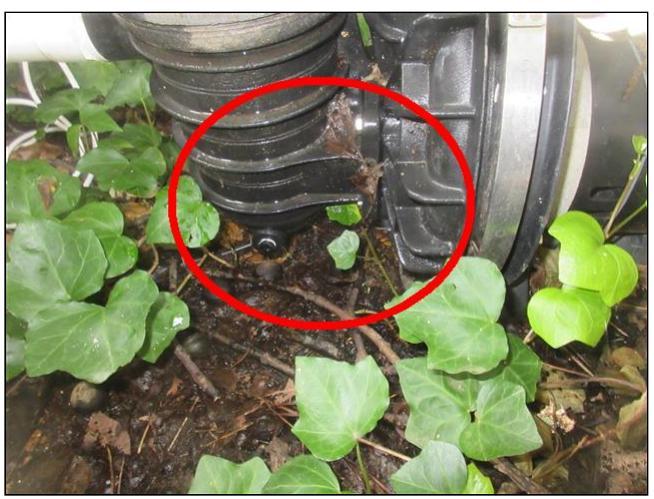
Clogged filter/Leaking Pump observed at the circulating equipment. Recommend repairs be made by a licensed technician for proper operation to prevent deterioration of the unit.

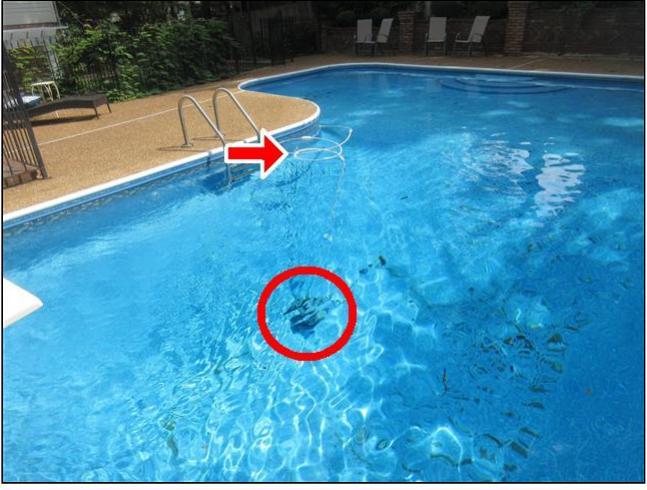
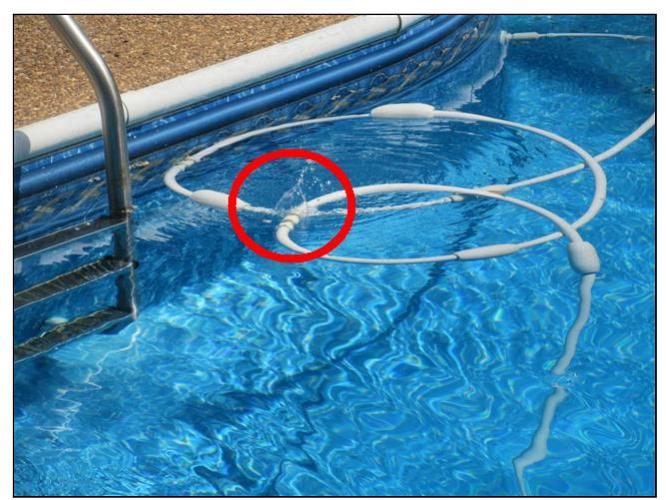
It appears that there may be an issue with the line of the pool vacuum/cleaner. Recommend repairs be made for proper operation.

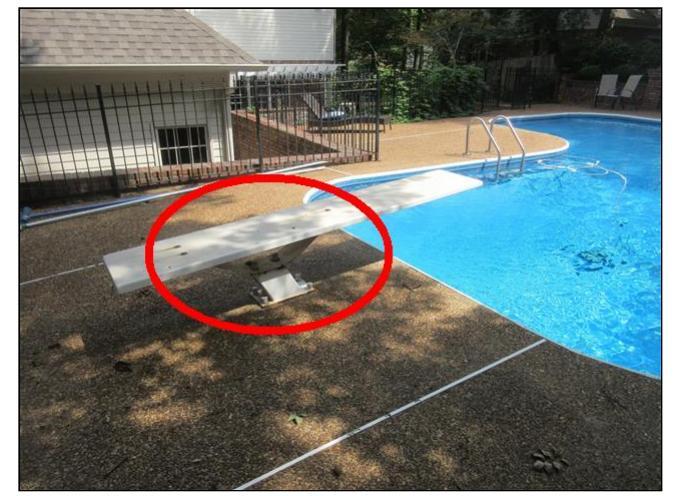
10.3 Item 1(Picture)

Although it appears to be operating properly, it is recommend to remove the diving board for safety.
