**AmeriSpec MidSouth**

**Doc #:** 201808-2531

123 Sample St

Germantown TN 38139

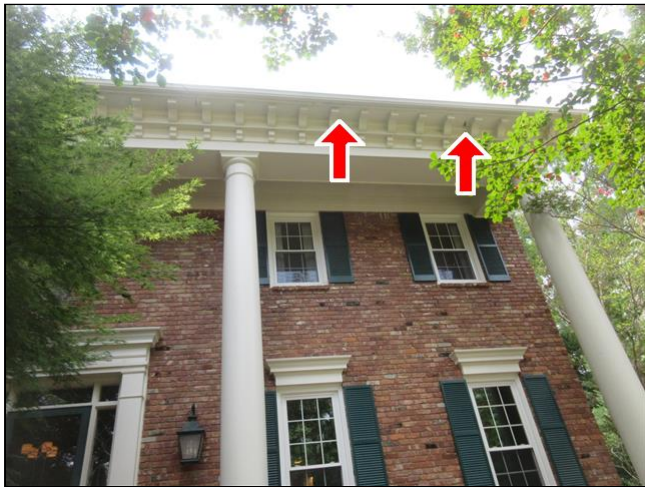
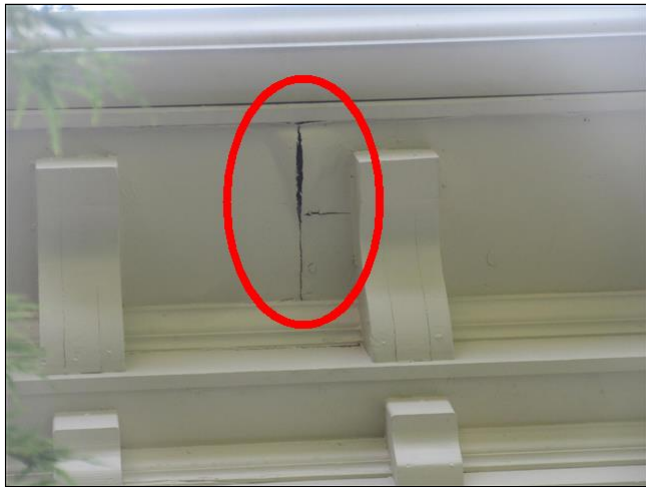
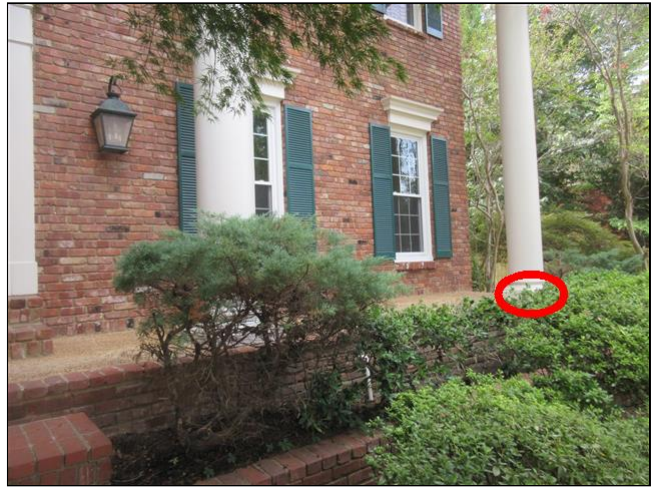
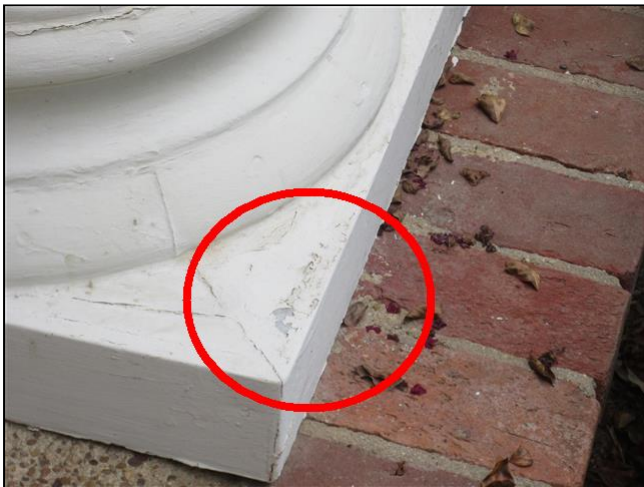
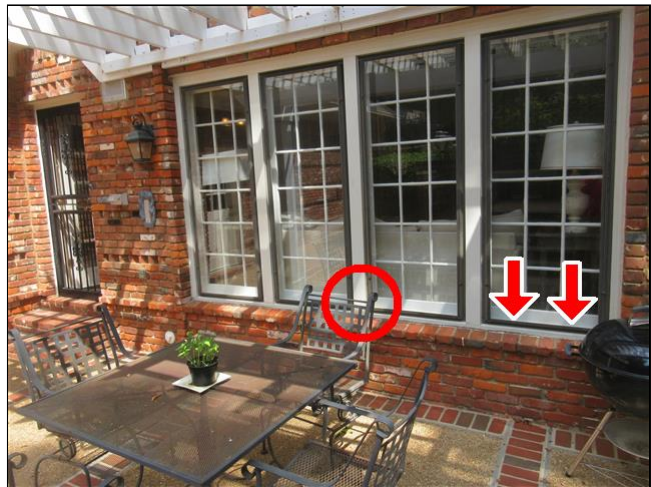
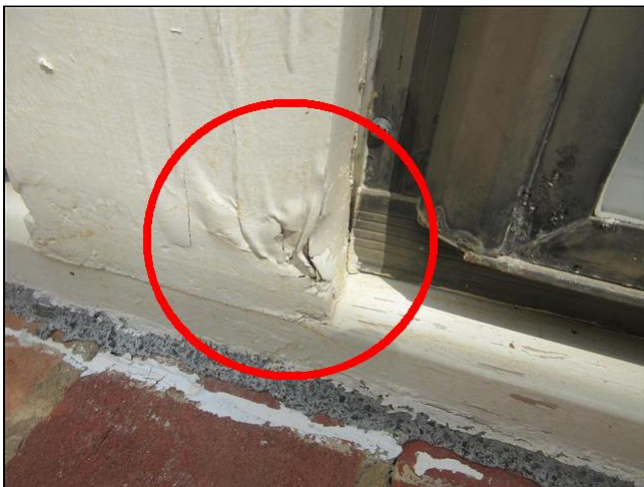
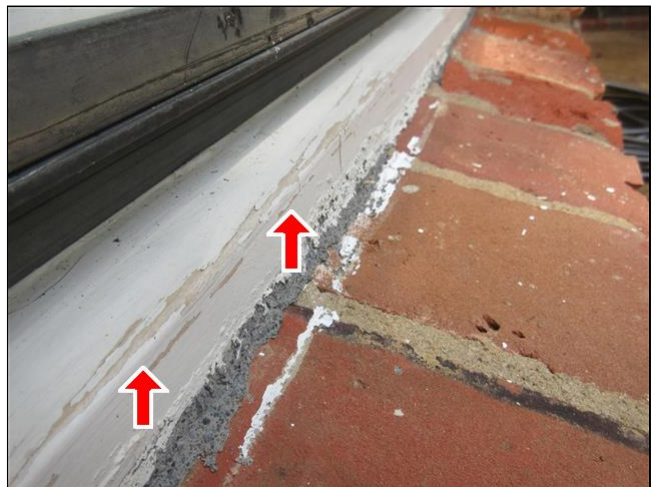
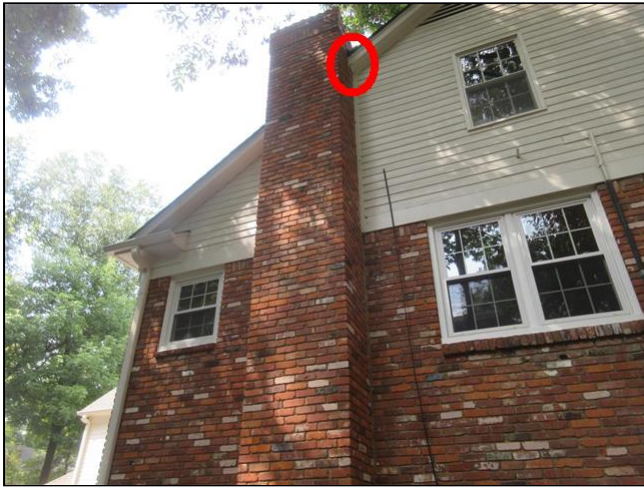
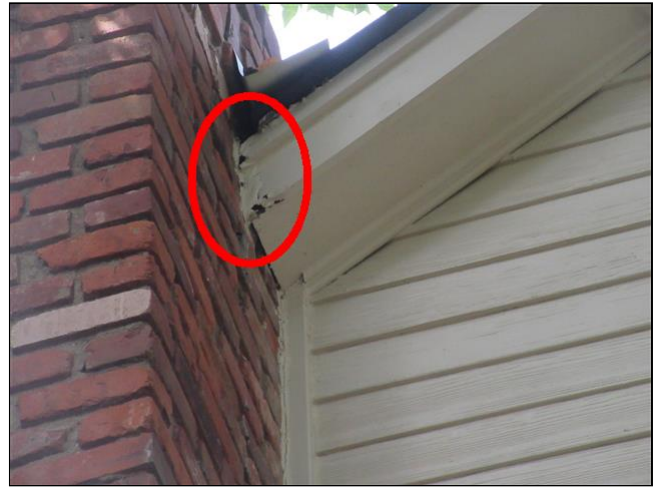
(1) Moisture damaged wood observed at various locations. The extent of damage could not be determined without destructive analysis (maintenance and/or repairs should be performed).

The wood trim needs primer and paint at various locations. I recommend a qualified contractor correct as needed.

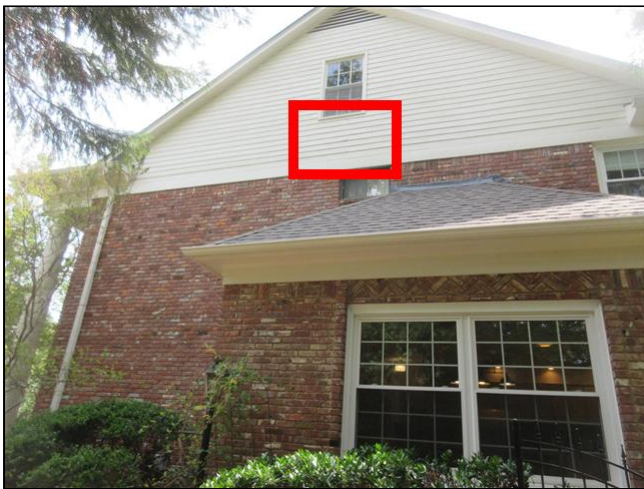
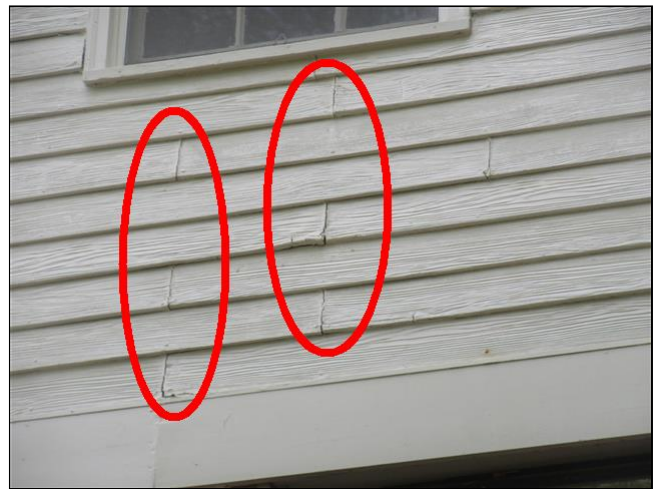
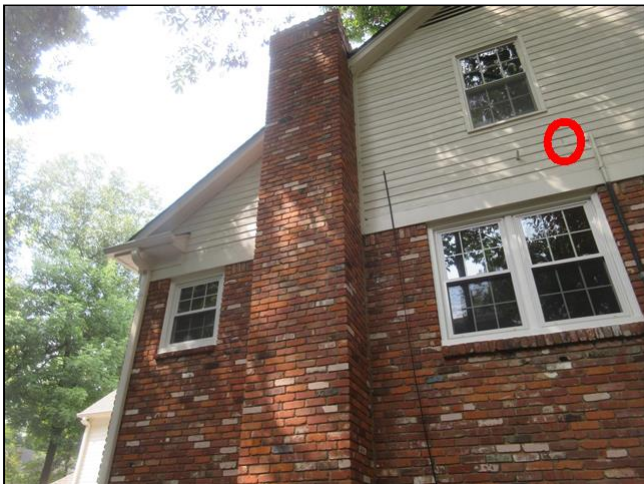
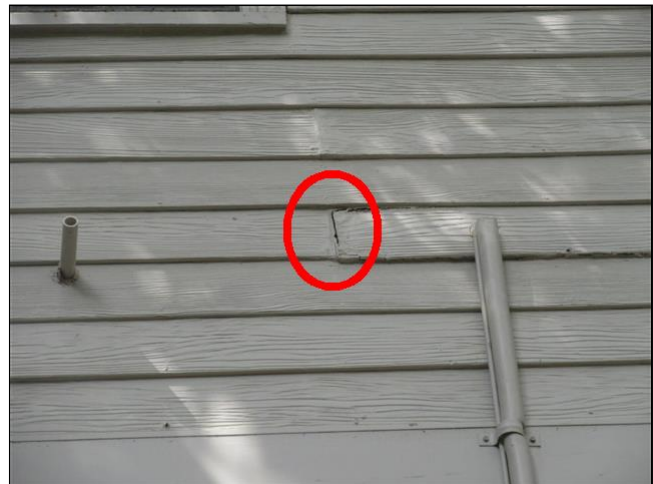
(2) Recommend adding caulk/paint to end joints of siding where necessary to prevent water penetration/deterioration.

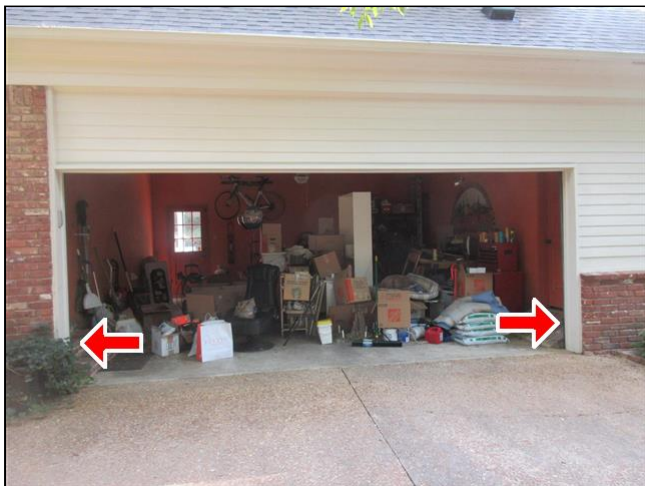
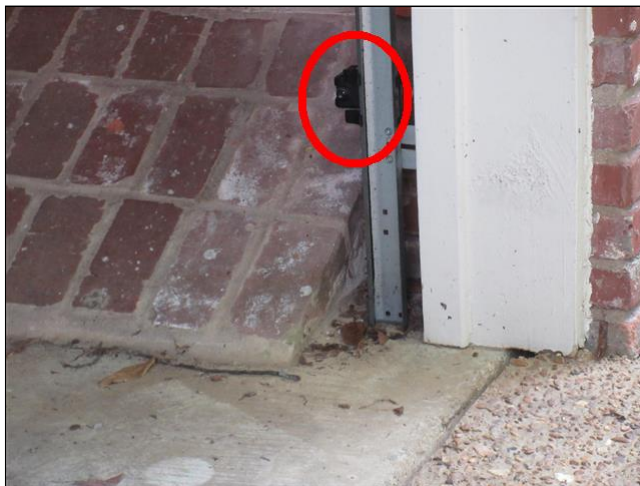
(1) The electric eyes are mounted too far above the floor to protect small children, pets, or property as intended by the manufacturer. We recommend lowering the eyes to within 6-8 inches of the floor or manufactures specifications.

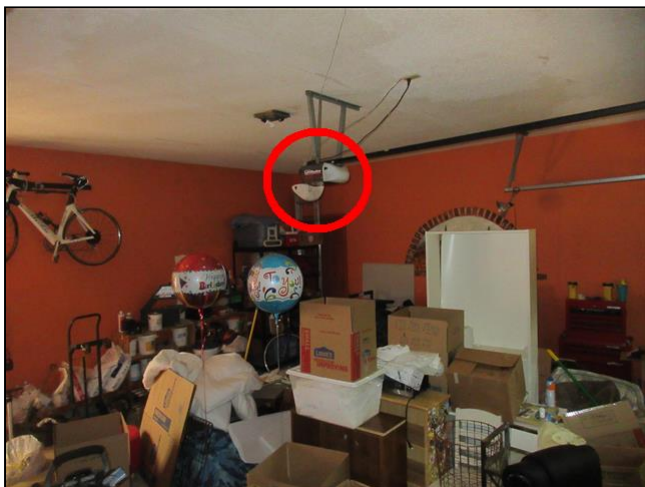
3.2 Item 3(Picture)

(2) The force activated safety reverse did not respond to test. This garage door opener is to be equipped with dual safety reverse devices, one of which did not operate when tested at the time of inspection. Recommend review for repair or adjustment, as necessary.

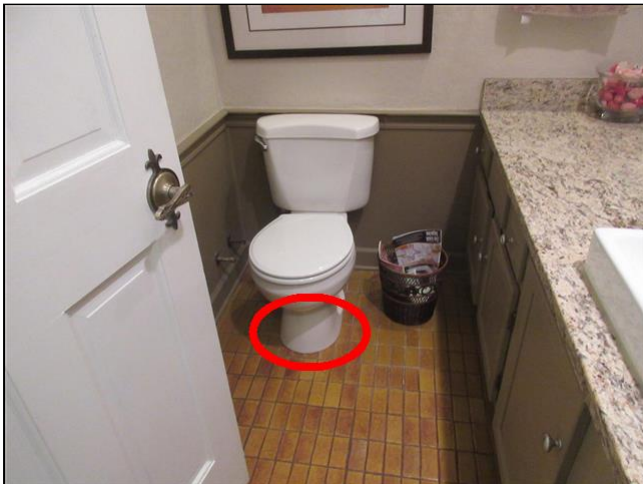
5.0 Item 1(Picture)

The toilet bowl is loose at floor anchor bolts in the first floor hall half bathroom. The wax ring inside the unit must have a snug, secure fit in order to keep from leaking. Properly re-sealing and re-securing this unit is suggested to prevent water leakage and damage to the sub-floor area. This type of damage is not always visible or accessible to the inspector at time of inspection. Recommend review by a qualified plumber for repair or replacement, as necessary.

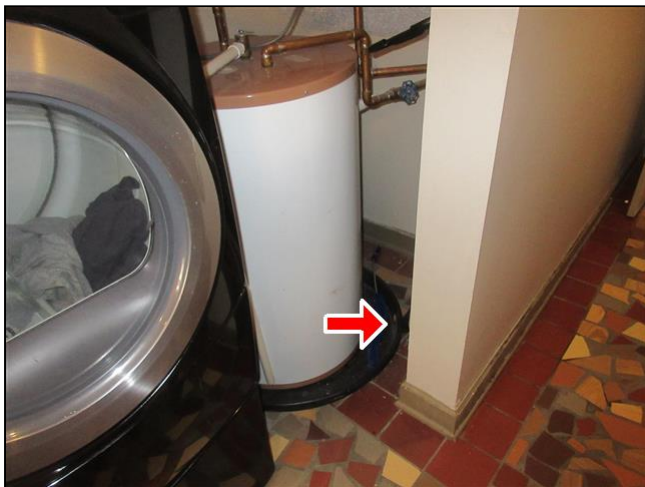
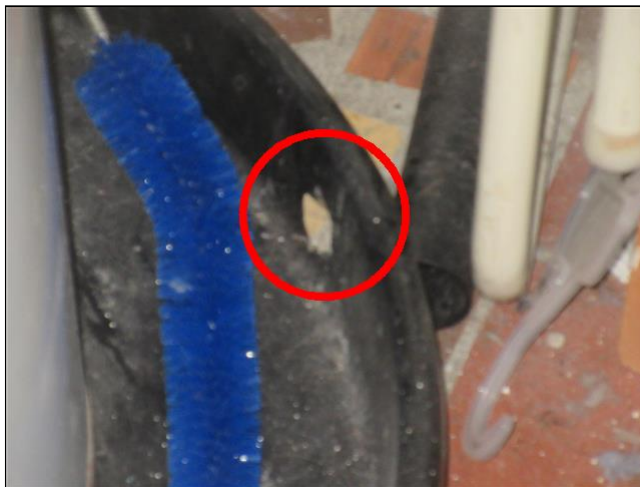
(1) Damaged emergency pan observed at the hot water heater located in the laundry room. Recommend repair/ replacement for proper operation.

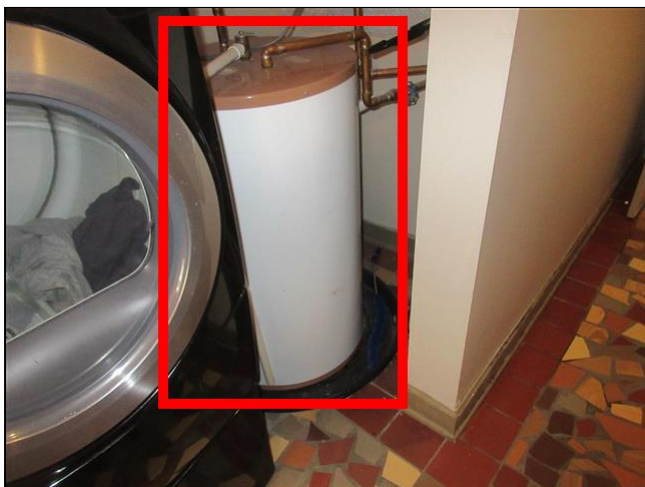
5.1 Item 3(Picture)

(2) In the inspectors opinion the water heater in the laundry room could be near the end of its useful life due to its age. Recommend review by a licensed plumber for repair or replacement, as necessary.

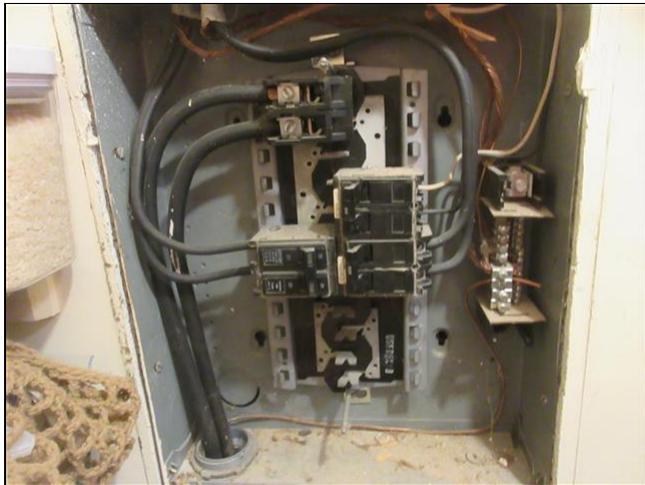
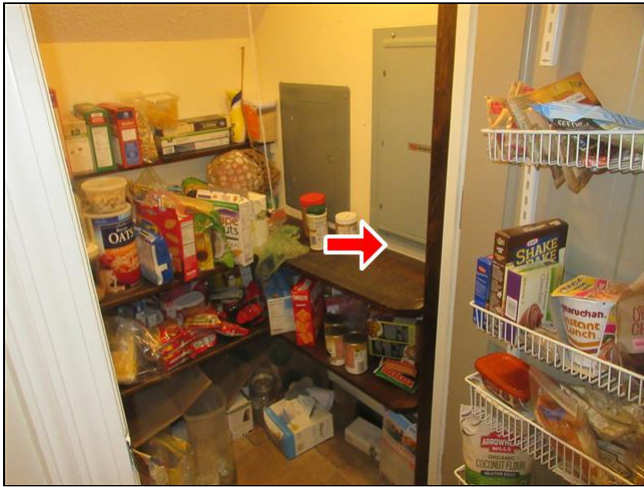
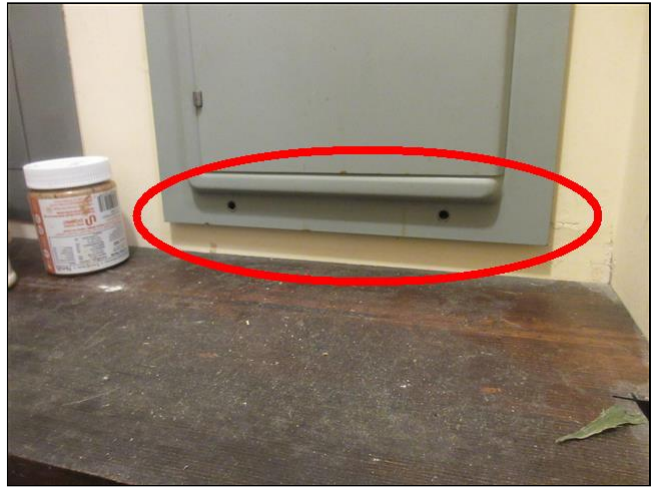
The main electrical panel is located along the right side wall of the kitchen pantry. The protective cover was removed for this photo and a more thorough inspection.

Recommend missing electrical panel screws be replaced for safety.

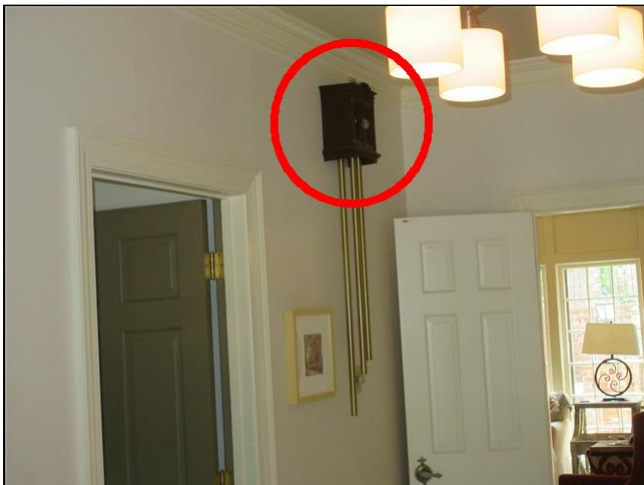
6.1 Item 1(Picture)

(1) Damaged doorbell observed. Recommend repairs be made for proper operation.

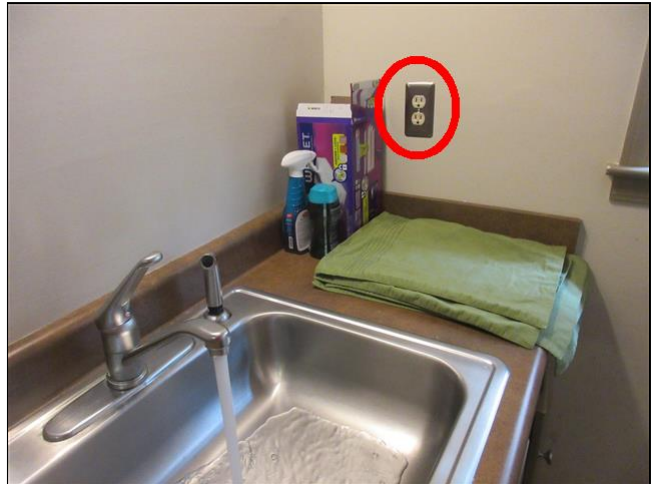
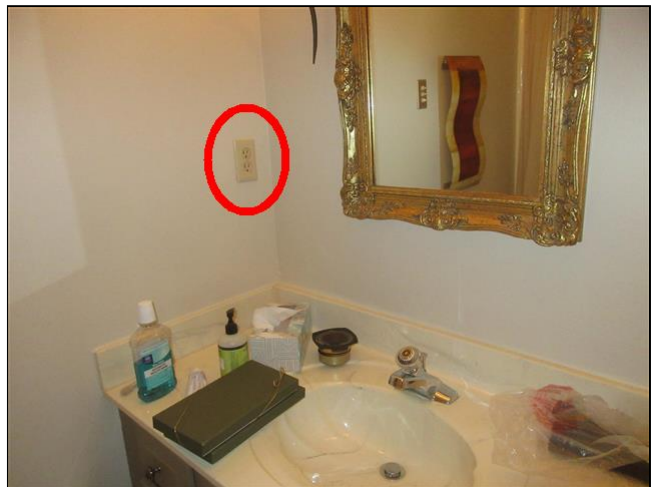
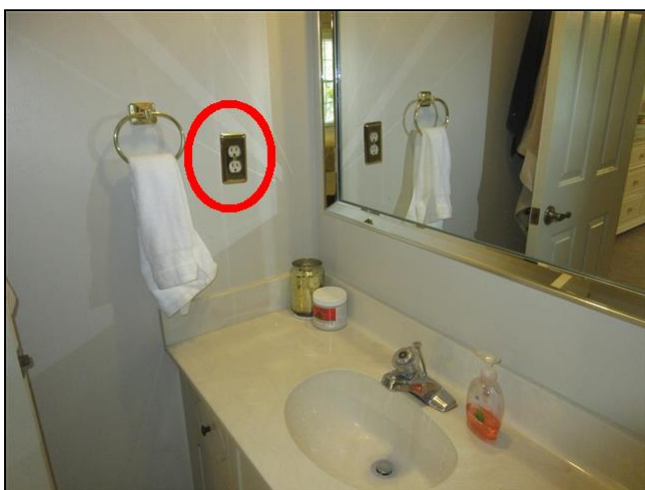
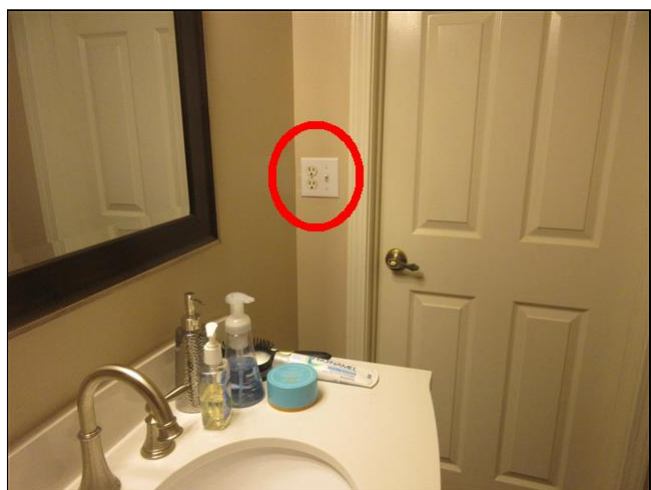
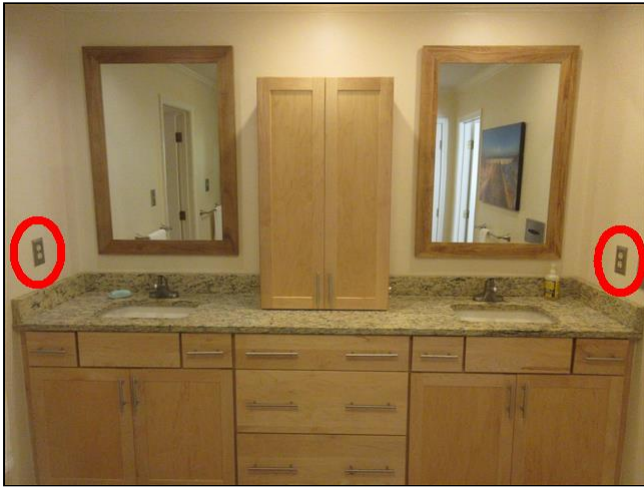
(2) Ground Fault Circuit Interrupters (GFCI) may not have been required when the home was built. Suggest client consider upgrading with ground fault circuit interrupters (GFCI's) at all receptacles near water sources, such as the kitchen, the bathrooms, the garage, and exterior receptacles to enhance safety. Upgrades should be performed by a licensed electrician.

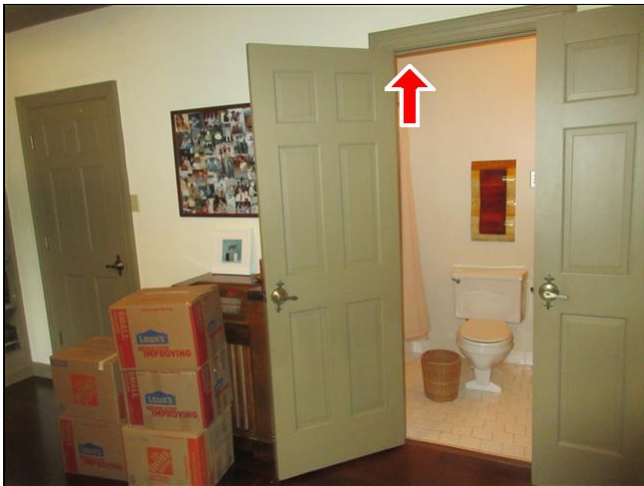
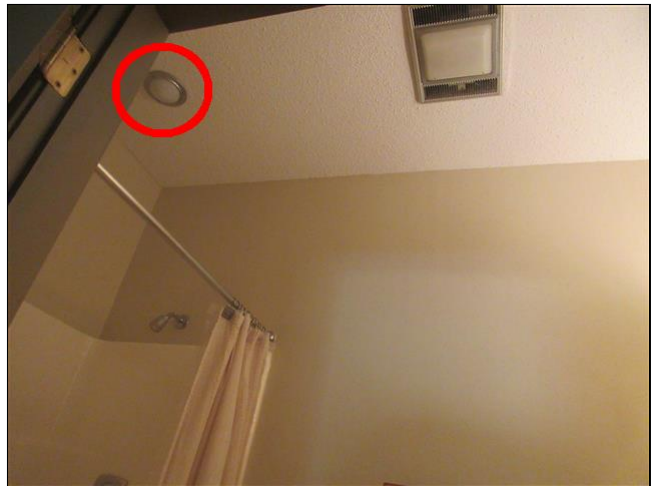
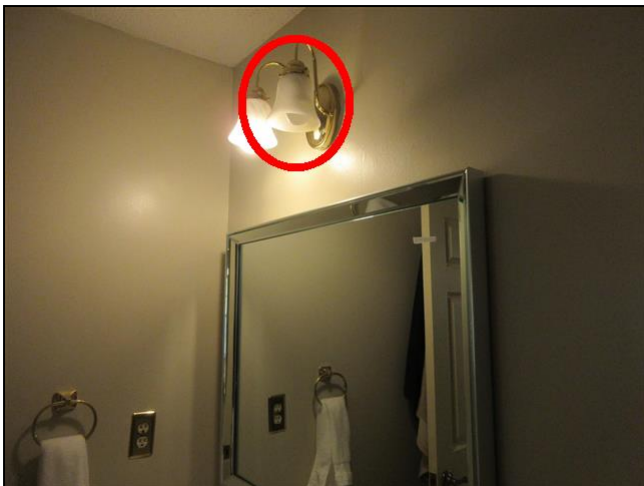
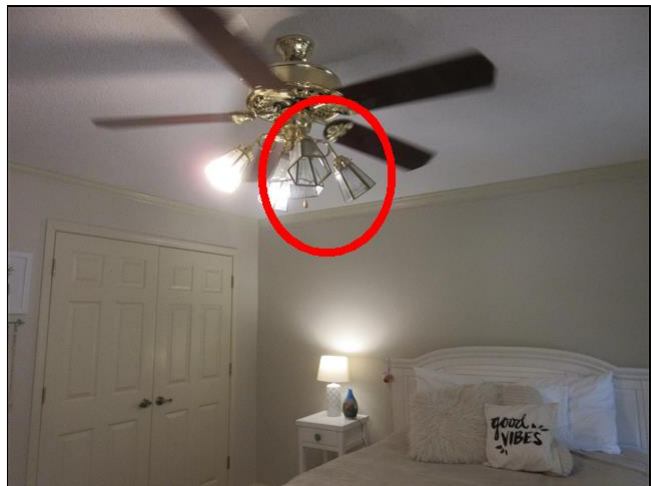
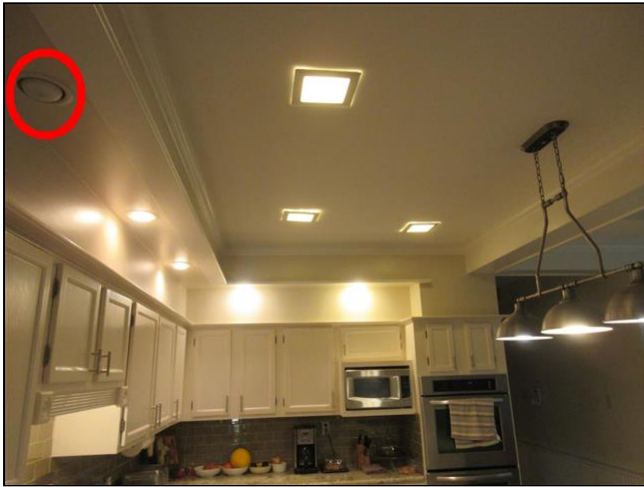
(3) Light fixtures in various locations were inoperative at time of inspection. Possible spent bulbs. Suggest client verify fixtures for proper operation prior to closing.

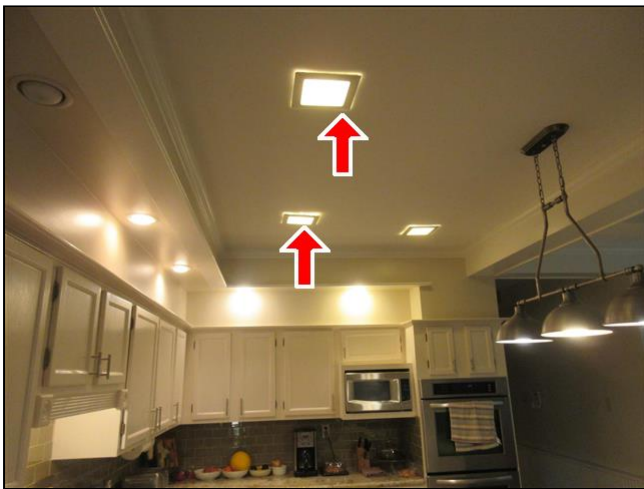
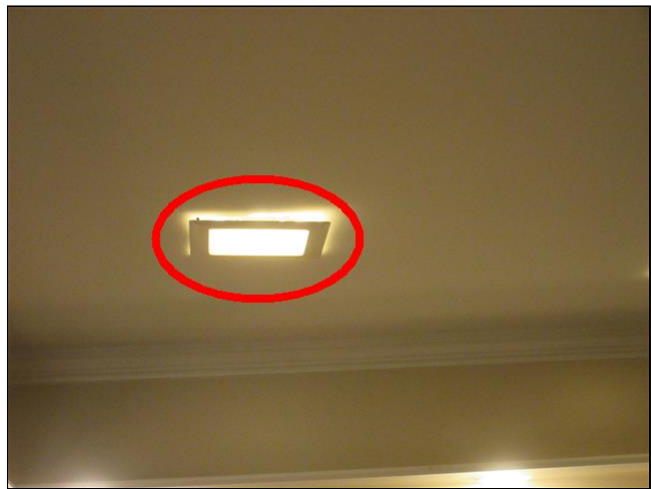
(4) Damaged light fixtures observed in the kitchen. Recommend repairs be made.

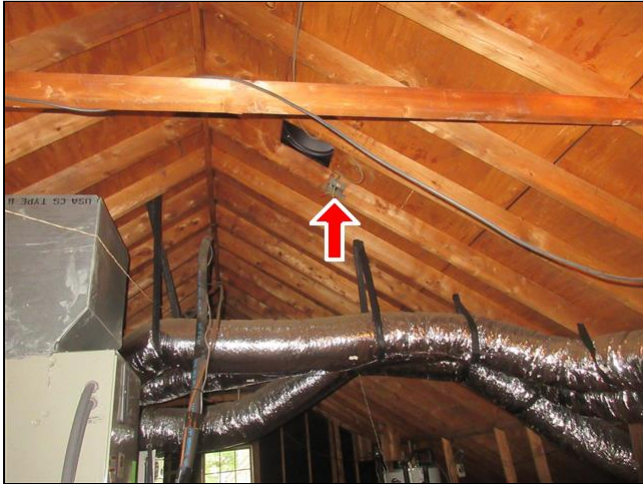
(6) Open junction boxes were observed in the attic. Whenever an electric wire is cut and reconnected, the 'splice' should be encased in a covered junction box to prevent shocks and separation of the splice.

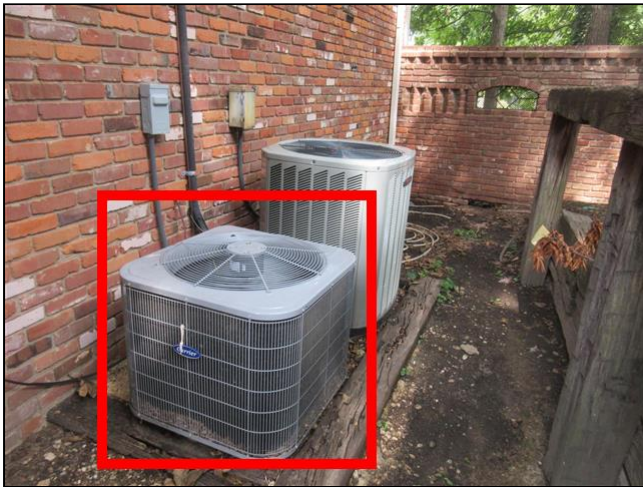
(1) Recommend having the condensing unit cleaned as part of routine maintenance.

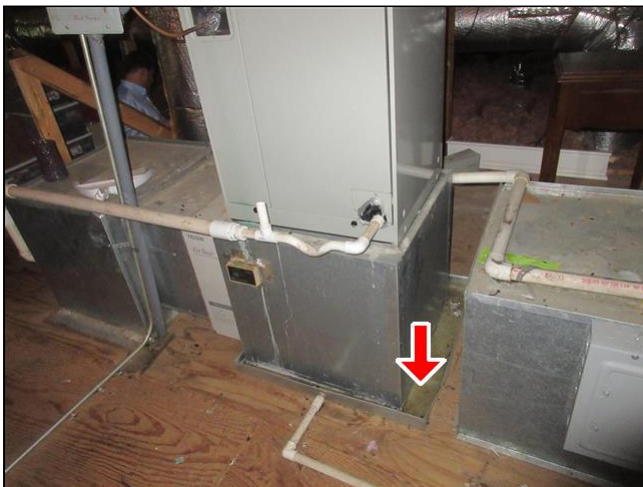
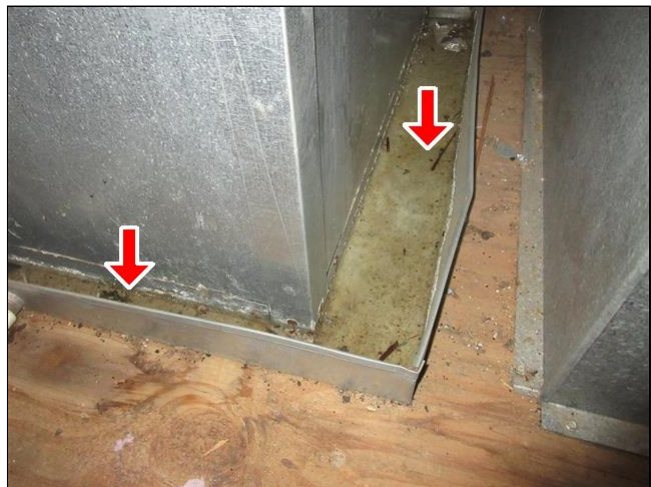
(2) Water observed in the emergency overflow pan of the HVAC. Recommend further inspection by a licensed HVAC technician for repairs/replacements to be made as necessary.

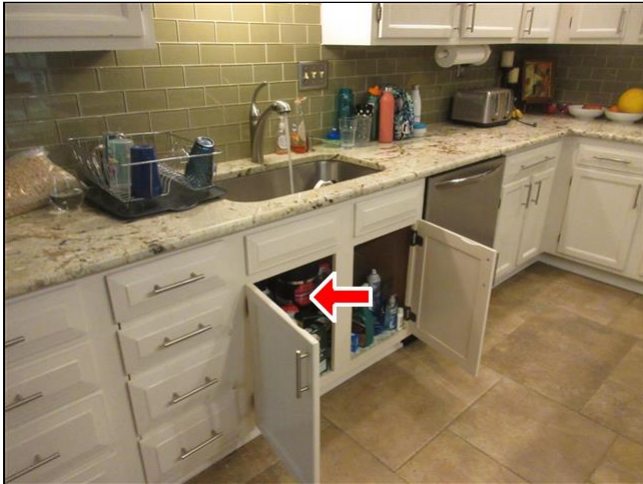
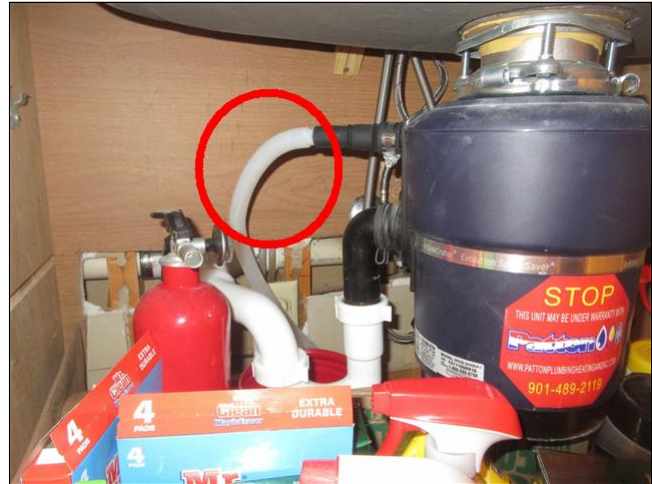
The dishwasher drain line needs to be looped upward near the top of the cabinet underside in order to prevent possible contamination of clean dishes which can occur when water from the sink flows into the dishwasher.

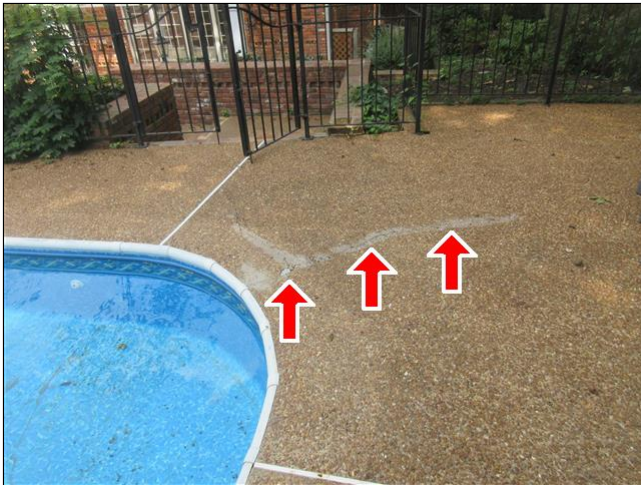
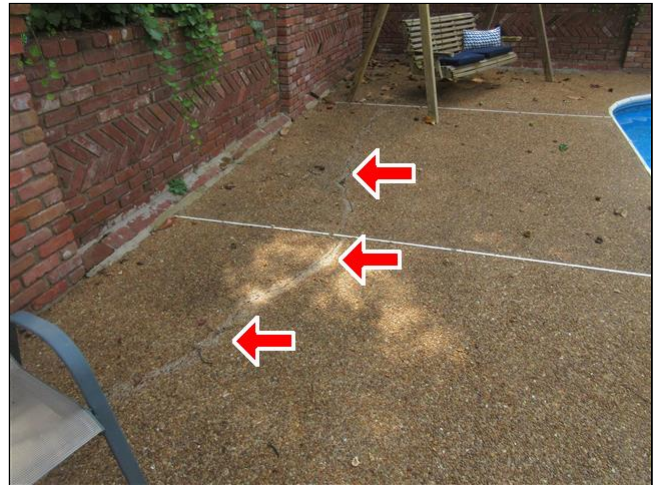
Recommend sealing pool decking cracks in the future to prevent water penetration.

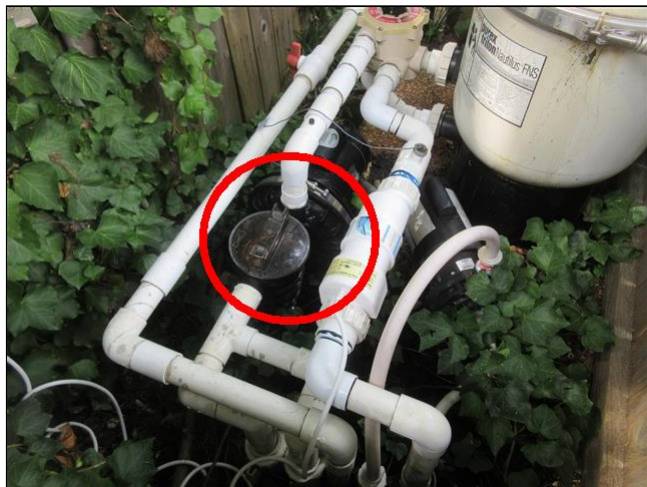
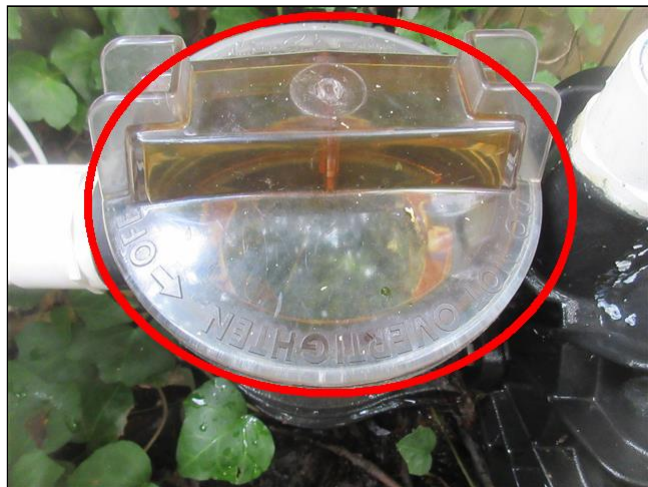
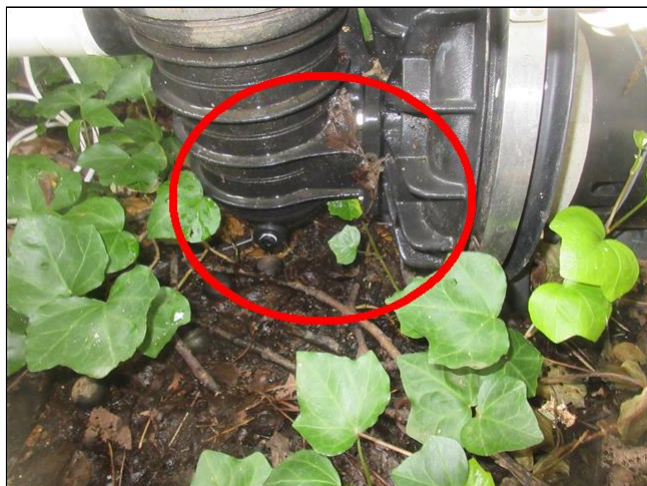
Clogged filter/Leaking Pump observed at the circulating equipment. Recommend repairs be made by a licensed technician for proper operation to prevent deterioration of the unit.

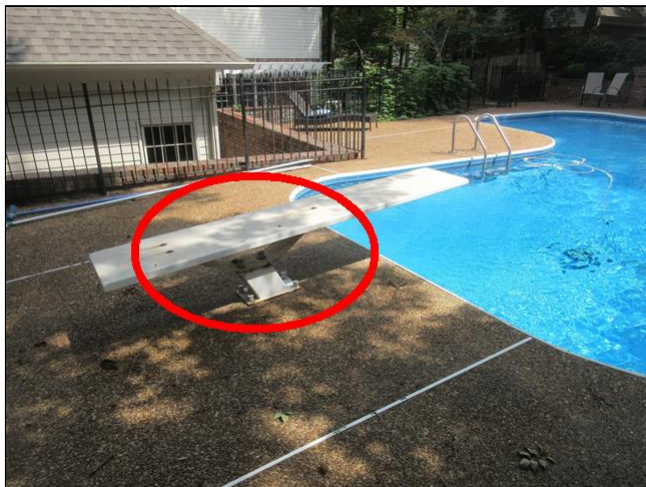
10.3 Item 1(Picture)

Although it appears to be operating properly, it is recommend to remove the diving board for safety.
